High Lakes Stabilization Clements Lake Construction Report

Uinta Basin Replacement Project

October 2008

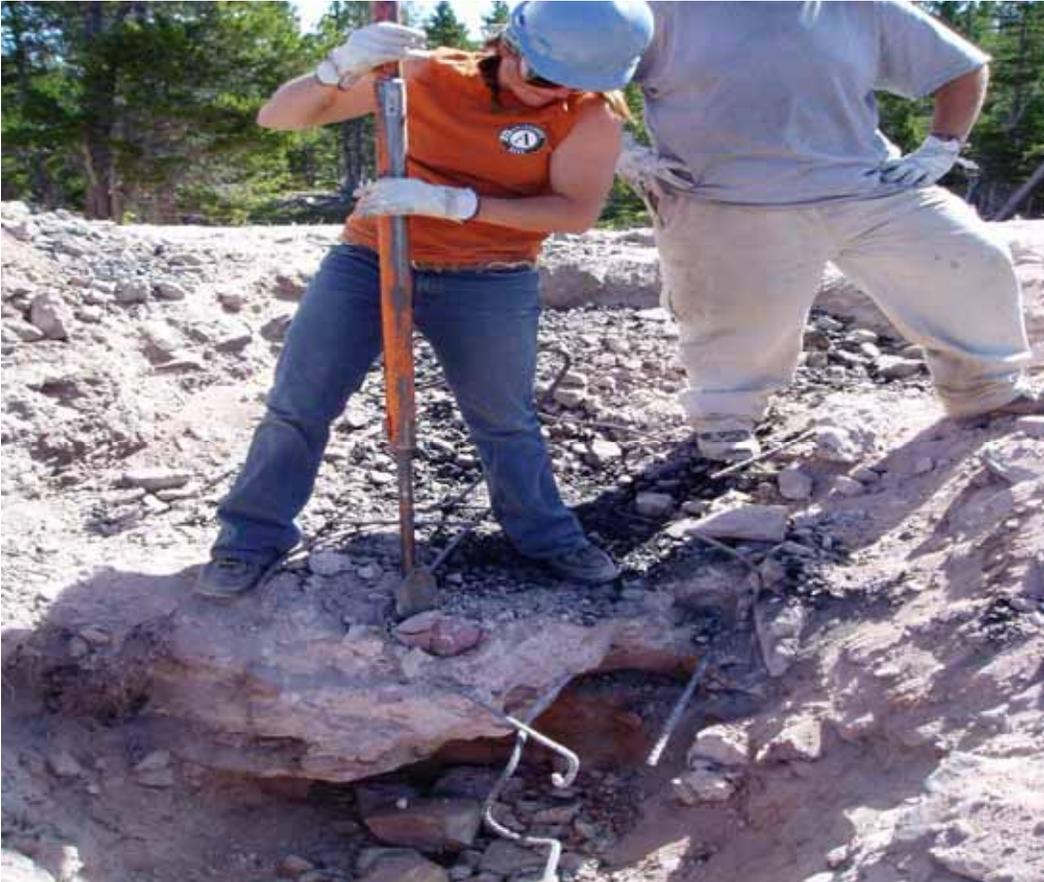
Figure 3 - Student Conservation Association Student Rose Stoppels breaking up the remainder of the vault.

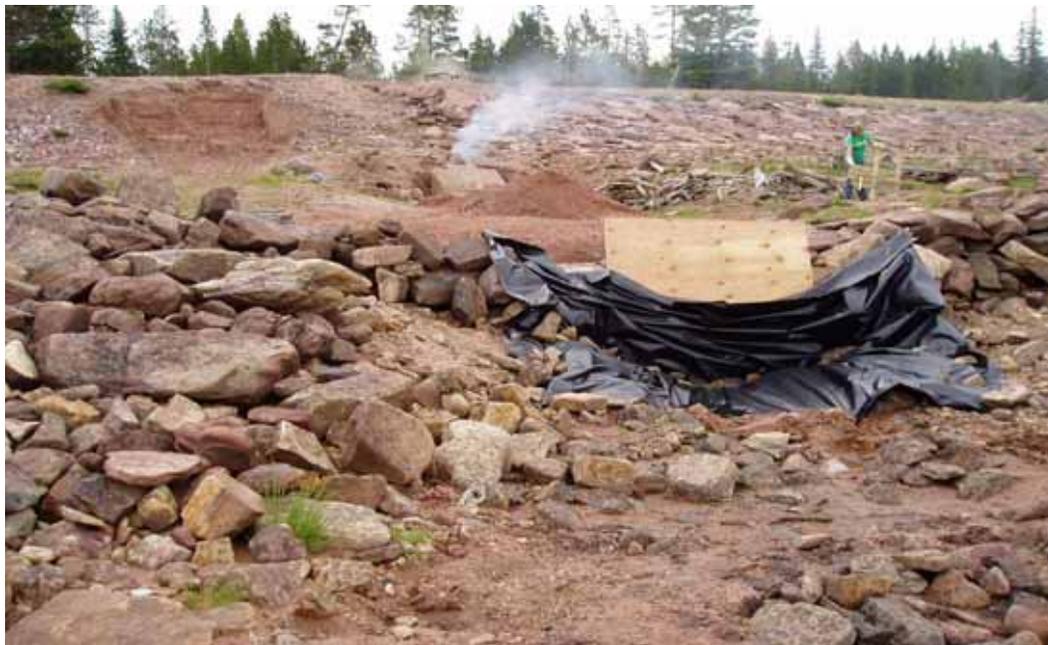
Figure 4 - The SCA used heat from burning logs removed from the shoreline to crack the vault and then break-up the materials with hand tools. Note start of excavation in the dam's embankment material. Riprap was stockpiled on both sides of the inlet channel for later use.

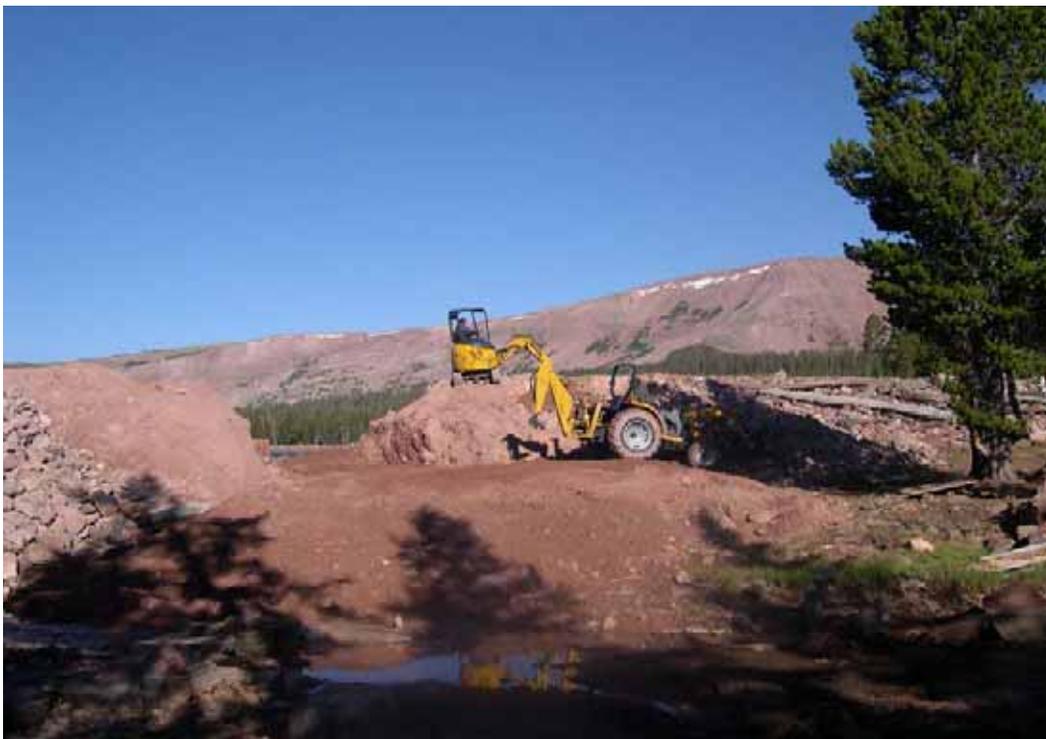
Figure 15 - Initial excavation through the dam. Tractor and mini-excavator are being used for excavation.

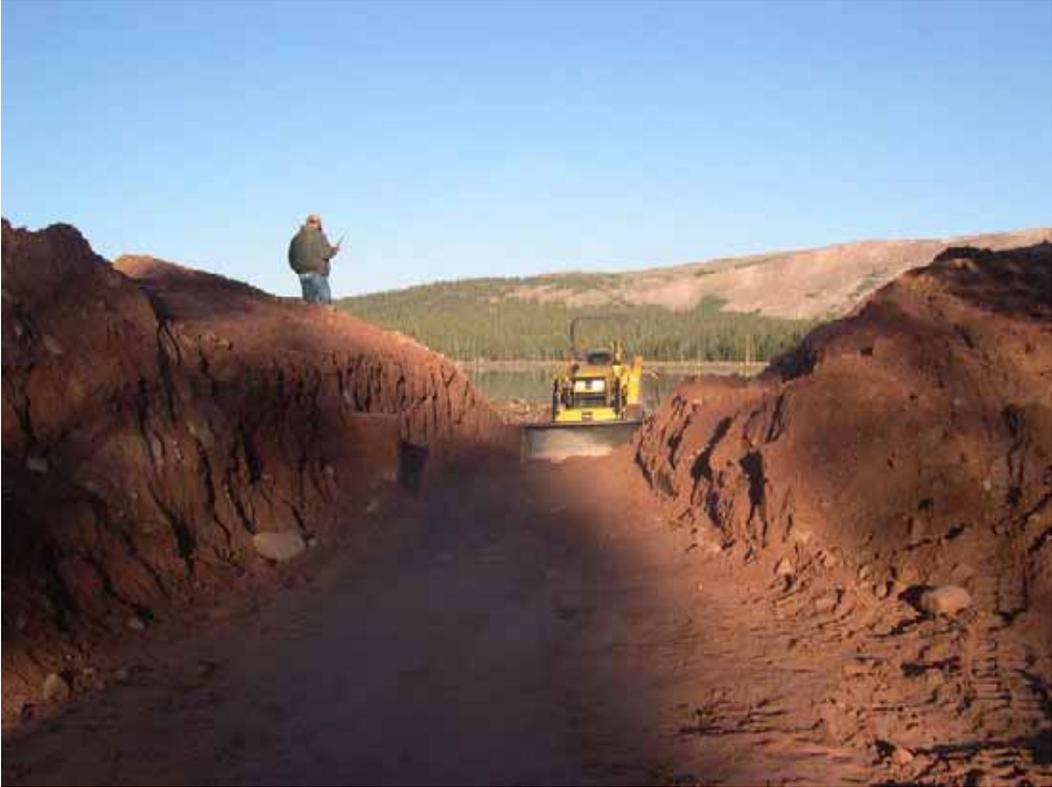
Figure 16 - Starting to widen bottom cut through dam embankment.

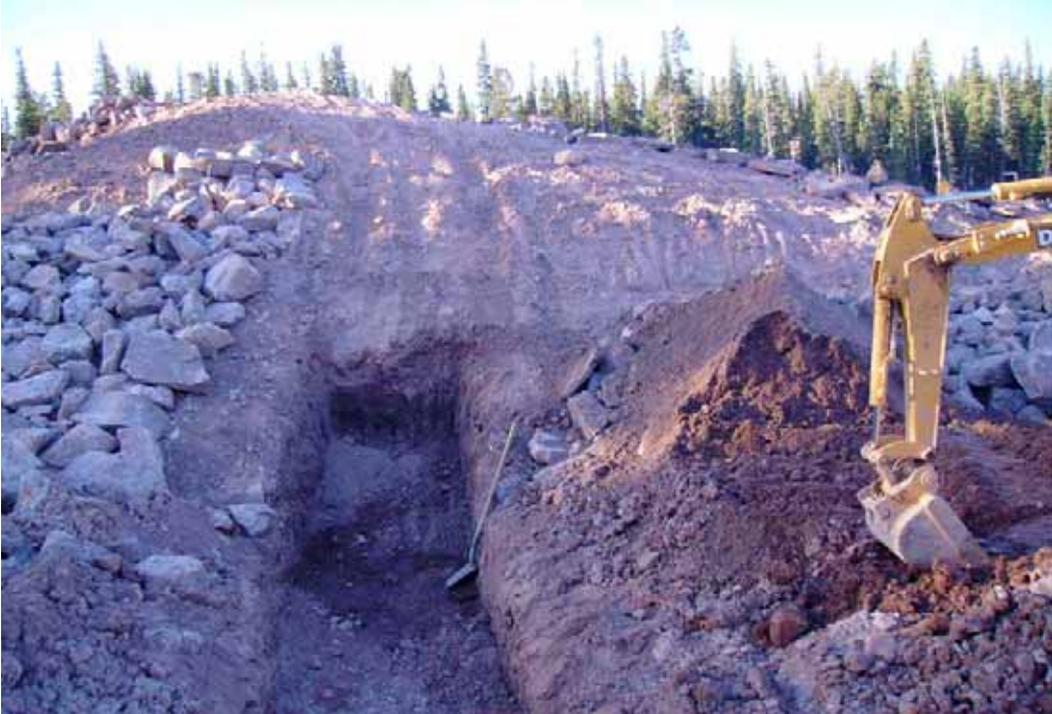
Figure 17 - Excavating middle cutoff trench.

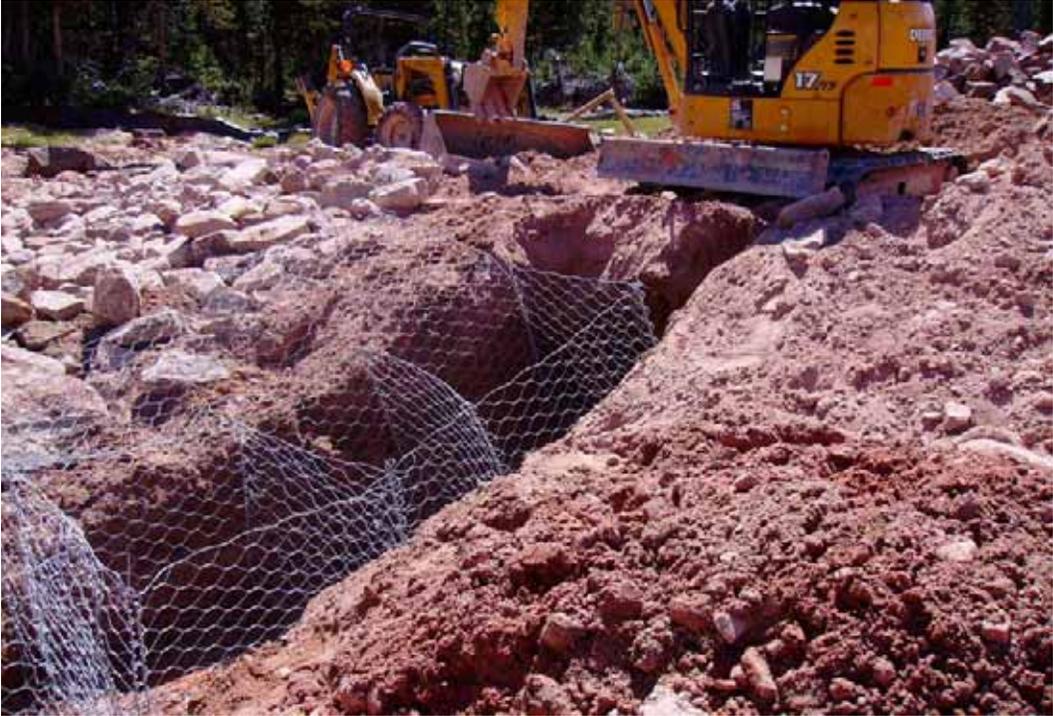
Figure 18 - Installation of the downstream gabion basket cutoffs.

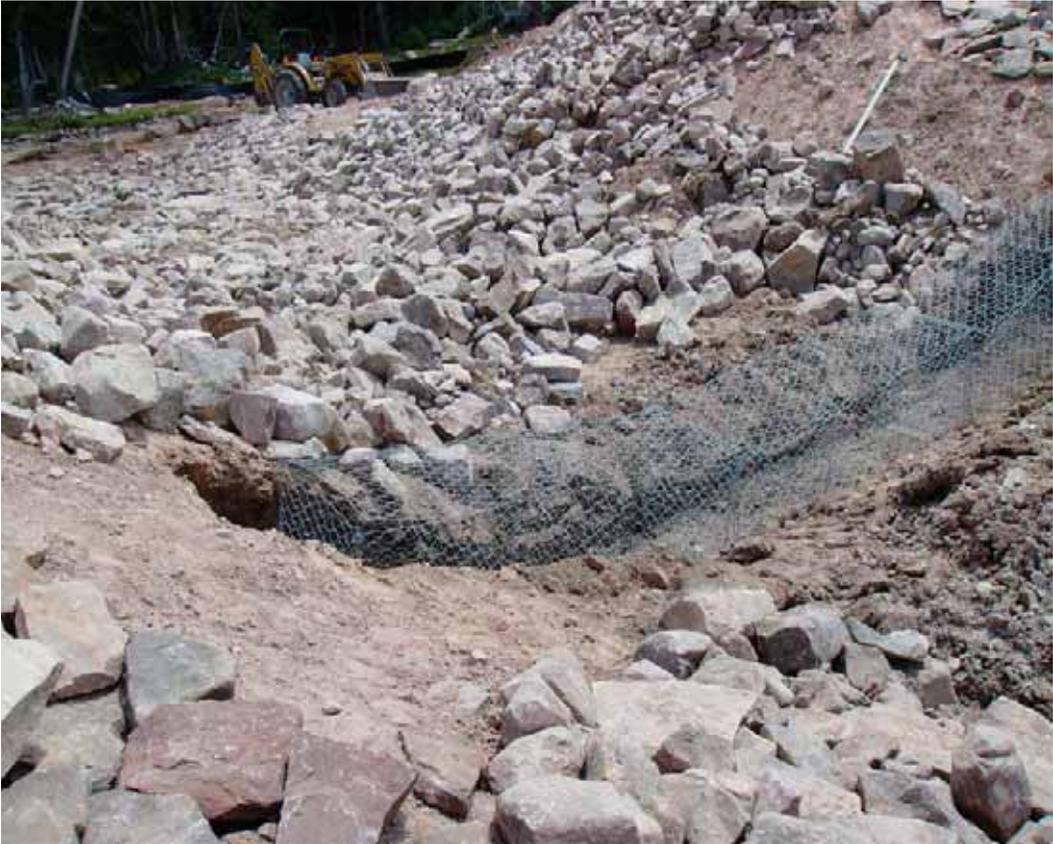
Figure 19 - Installation of the upstream cutoff wall.

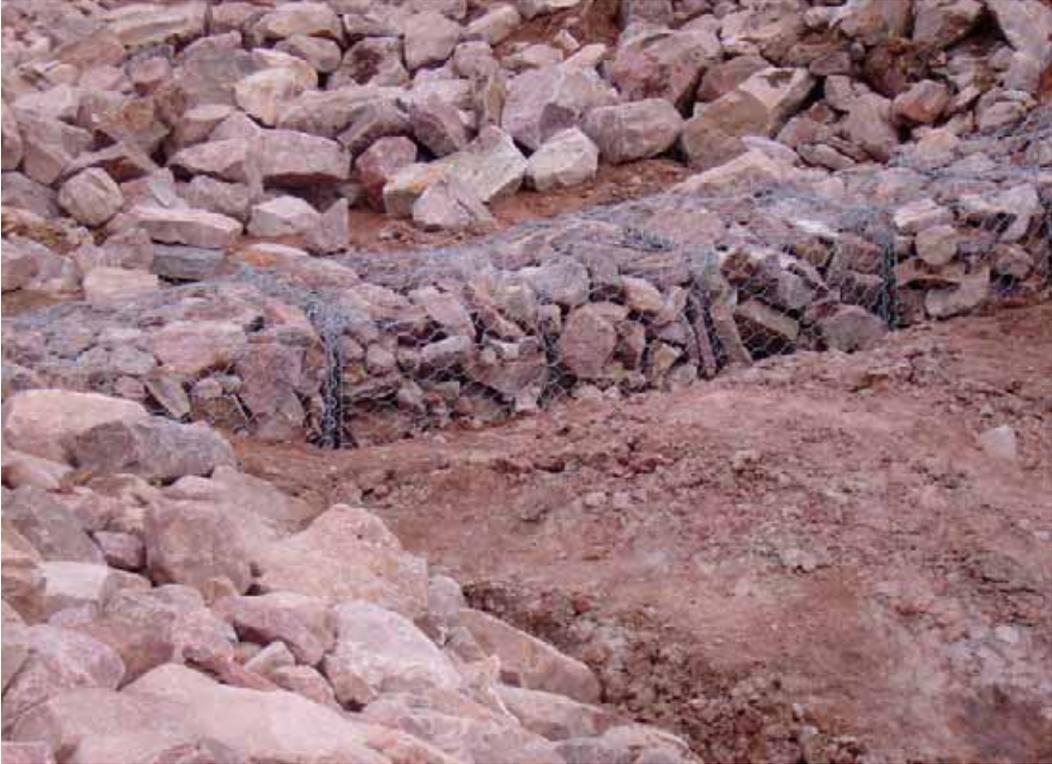
Figure 20 – Rock filled gabion baskets.

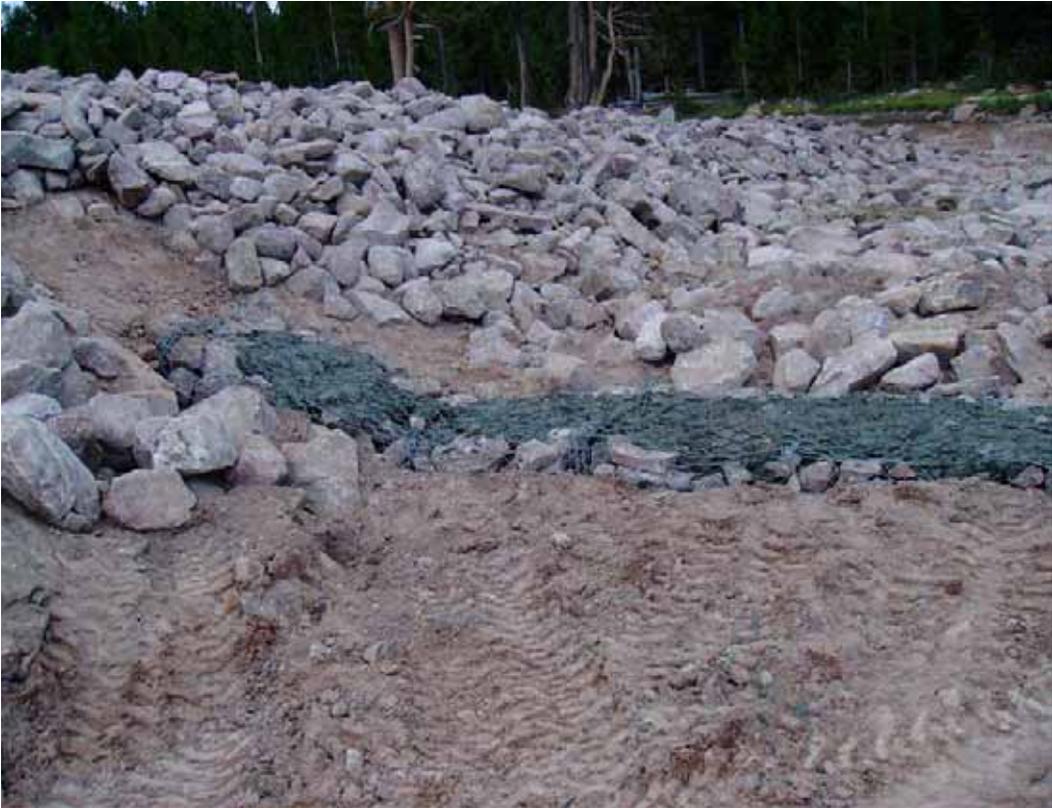
Gabion baskets were utilized to establish grade control through the excavated breach. A trench was excavated in the bottom of the breach with the mini-excavator. The gabion baskets were placed in the excavated trench and filled with graded rock material. The graded rock material was then grouted with Five Star Grout and/or cement to fill the voids. The gabion baskets were then covered with riprap to conceal the appearance of the cement grout.

Figure 21 - Gabion baskets after grouting voids.

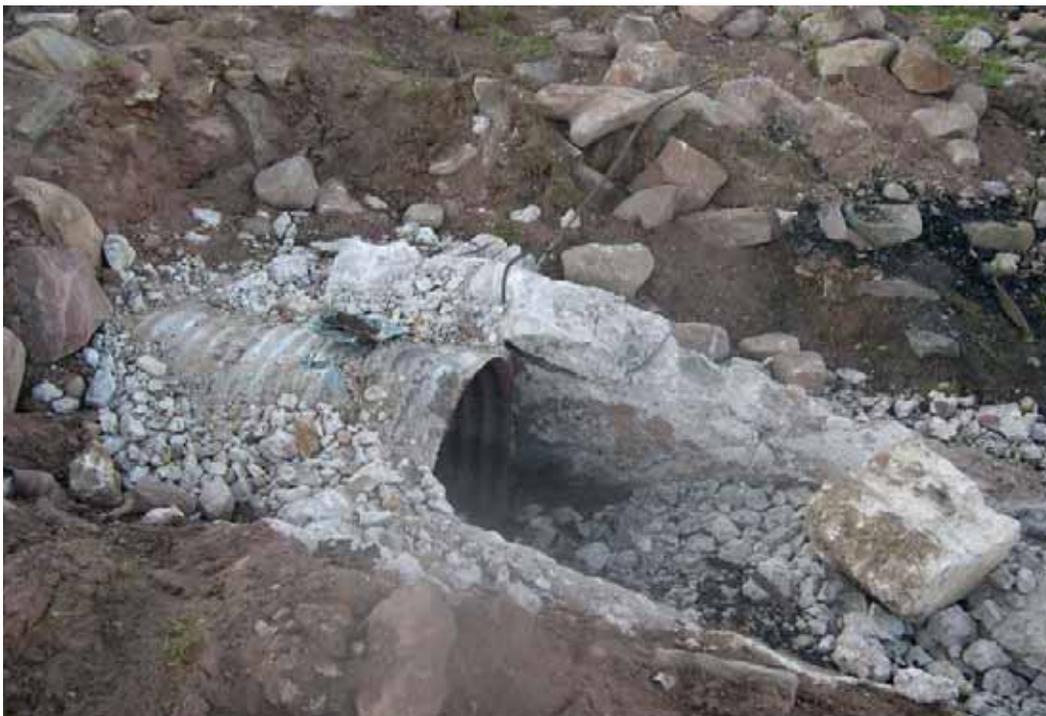
Figure 23 - View of inlet structure prior to backfilling with grout. Demolition was accomplished by heating structure with fire to weaken concrete and using hand tools to break up concrete around the pipe. Demolition performed by SCA crews.

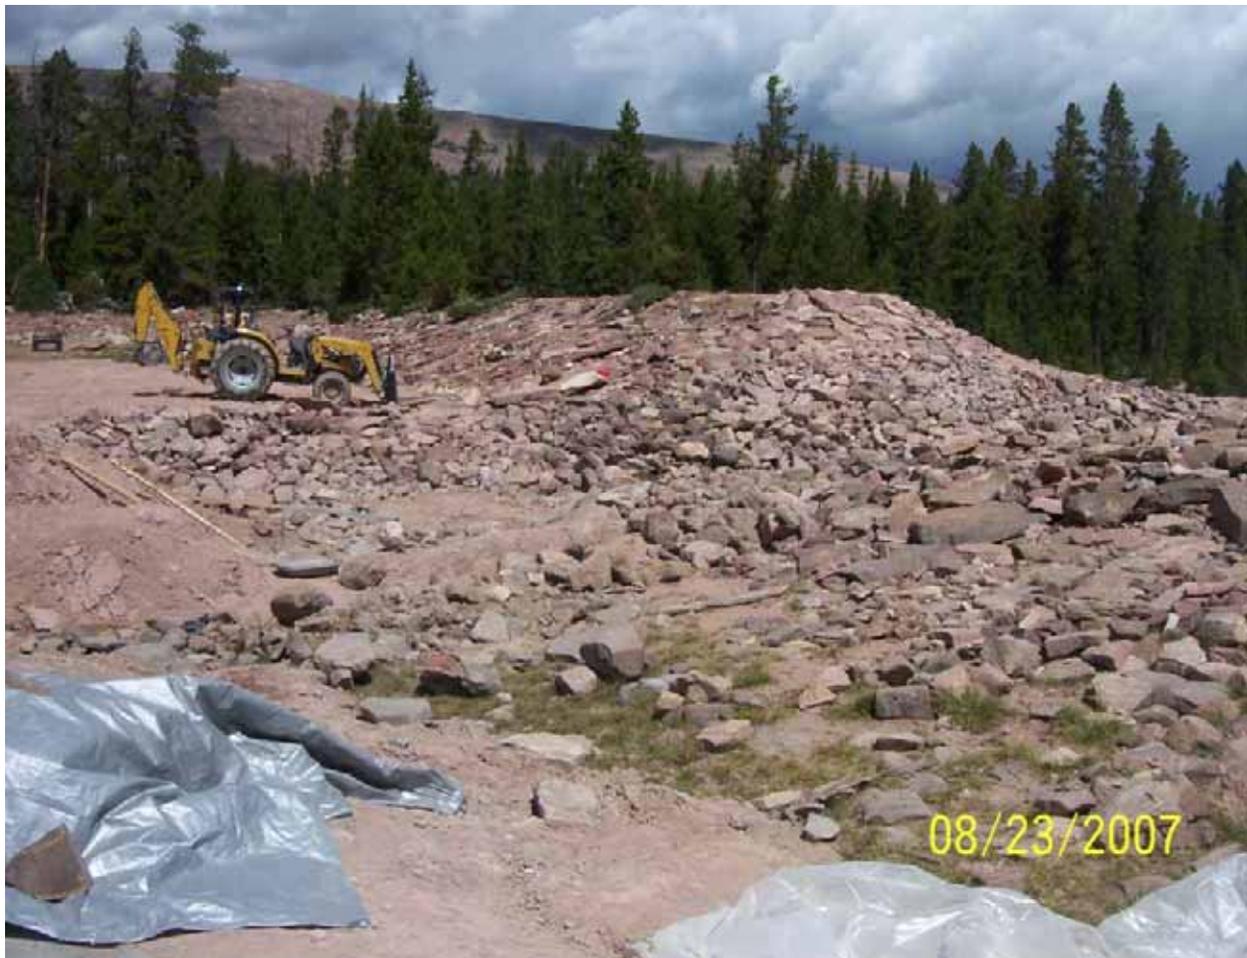
Figure 24 - View of dam site during construction as breach and inlet lining is progressing.

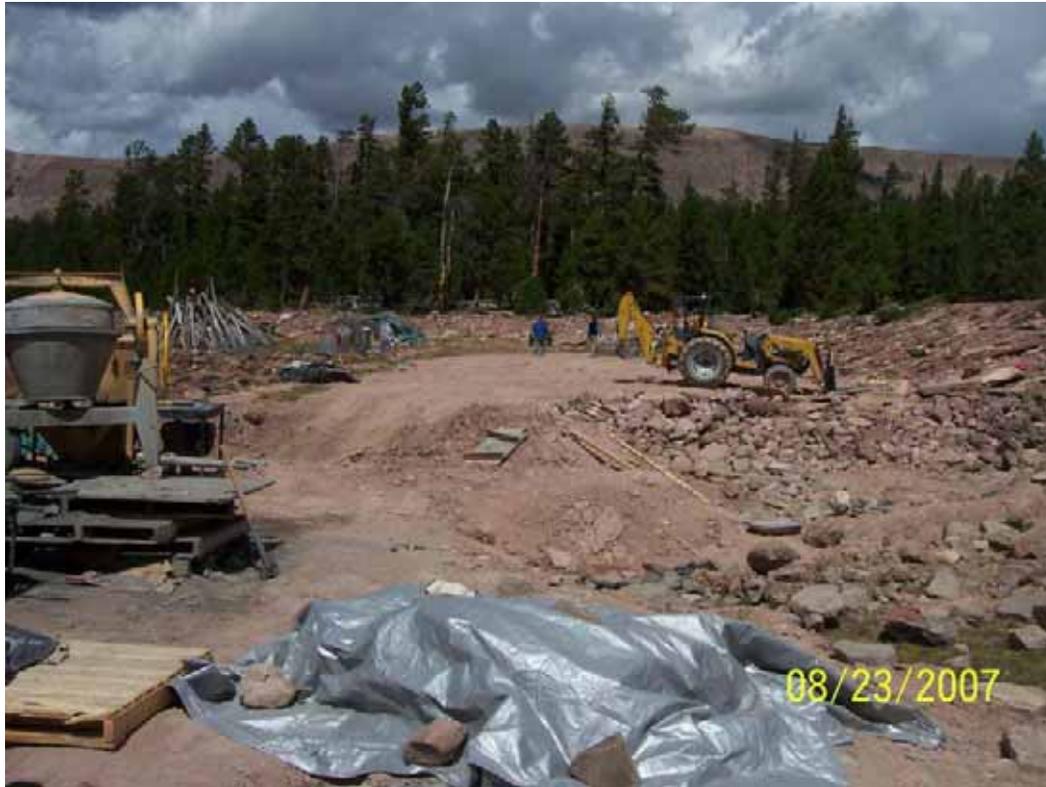
“The pipe has been grouted so that there are small if any voids in the outlet pipe. This was done by 5 different grout pours due to wrong type of pump, pump break downs, and insufficient labor force during the last grout pumping operations. This will create random cold joints. There is a presumed grout placement drawing attached to this document. The top of the grouted outlet pipe is approximately 1.5 feet below the channel and it was agreed that the grouted outlet pipe would have very little head on it.”

Figure 25 - View of work area during outlet grouting operation. Note inlet channel remaining to be lined with riprap.

It is recommended that future grouting operations include the use of an additive to increase the grout flowability and not use a heavily-sanded cement product. Straight cement mix and water with a plasticizer additive (for flowability) is recommended.

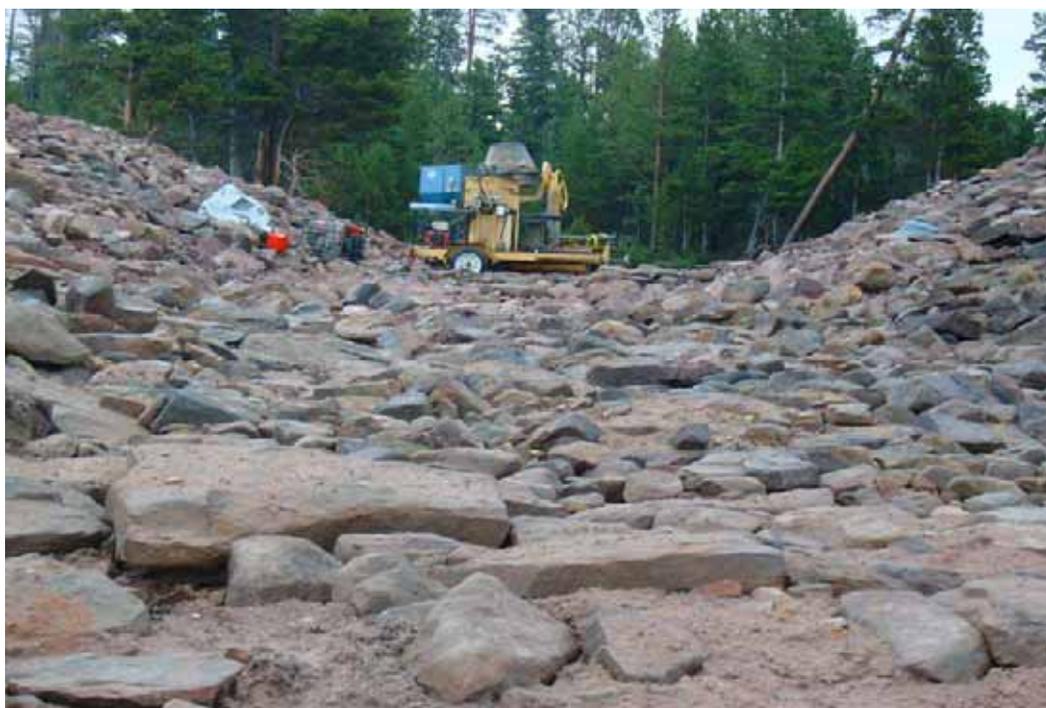
Figure 26 - View looking downstream through the excavated and rip rap lined breach. Note grout plant that was positioned to grout the outlet pipe.

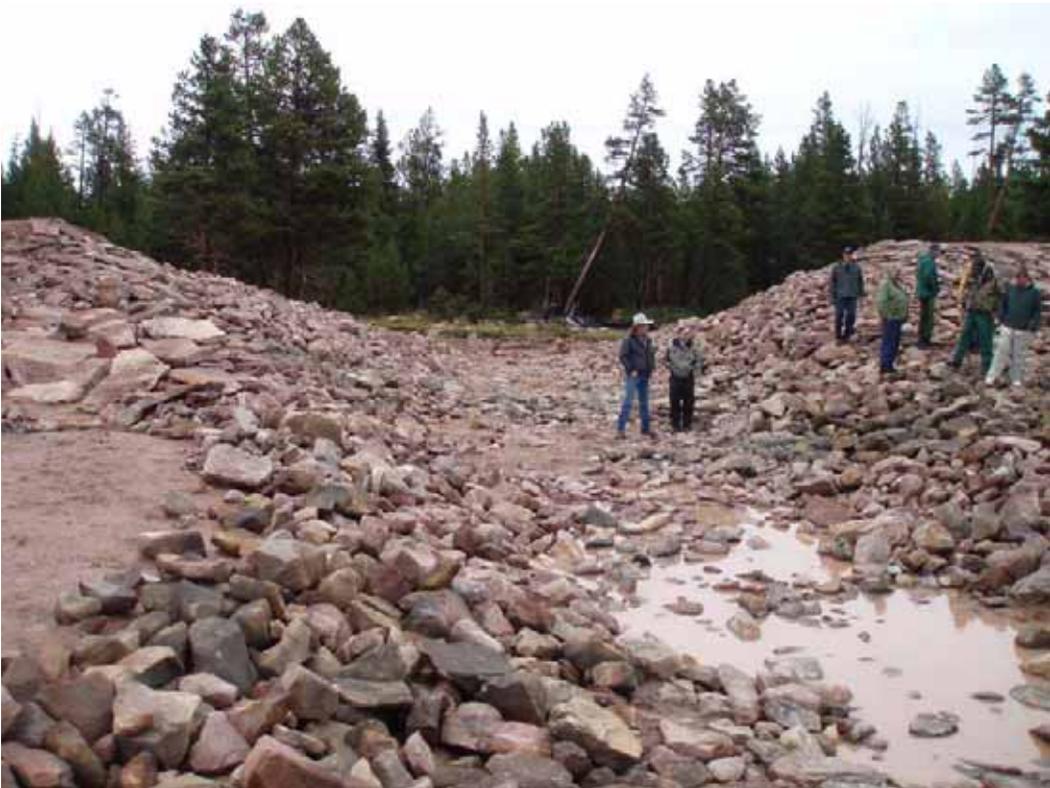
Figure 27 - View of group discussing the completed stabilized breach through dam embankment.

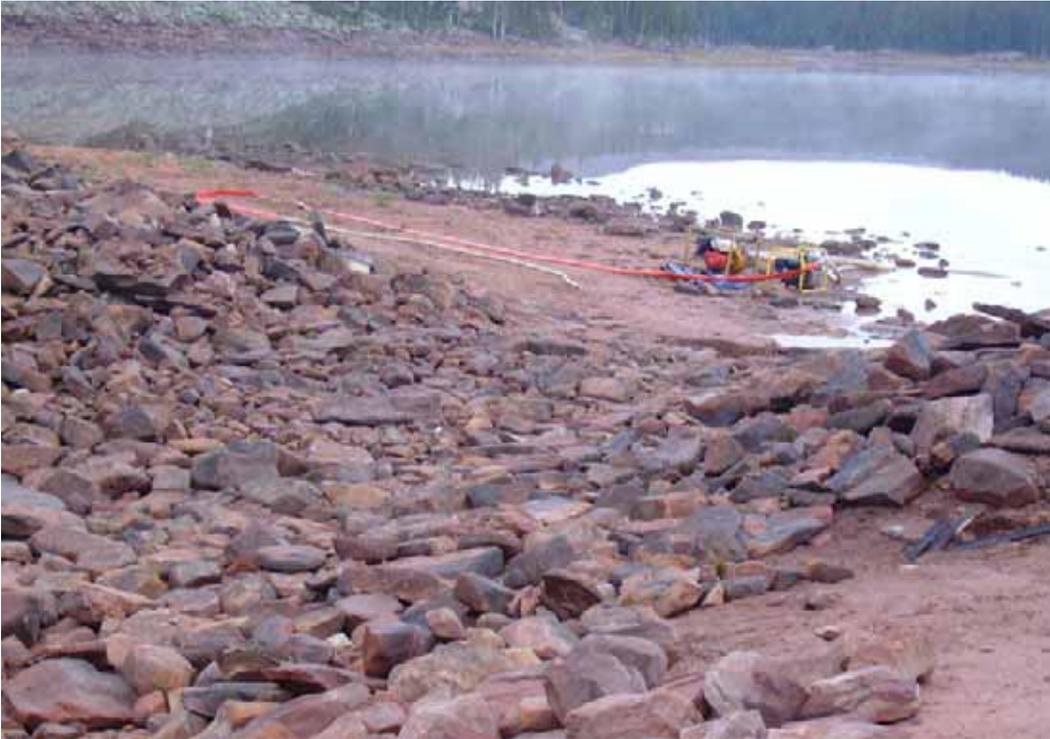
Figure 28 - View of finished upstream inlet channel graded and lined with rip rap.

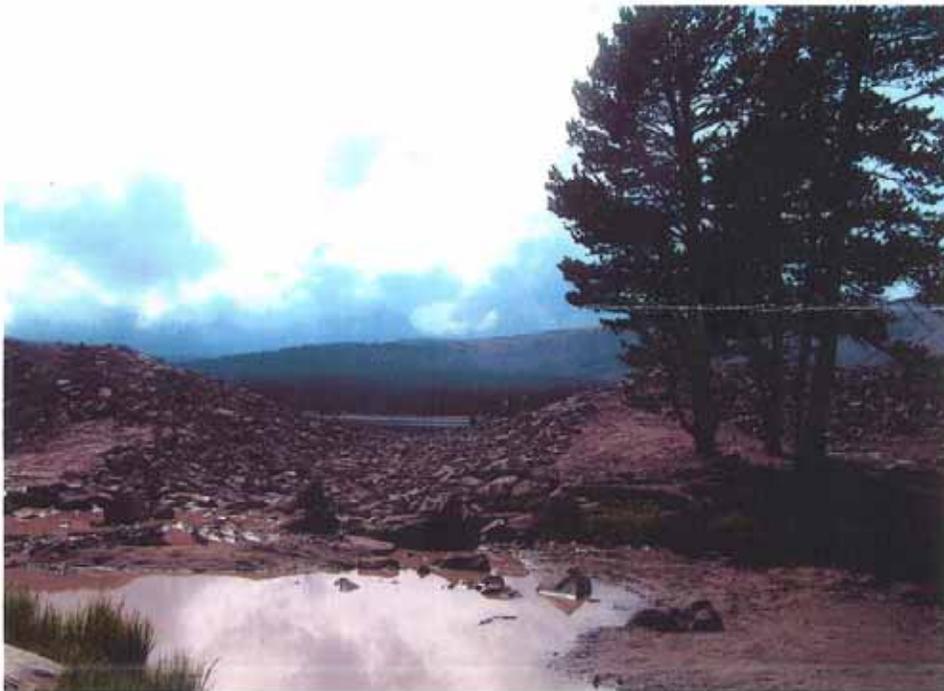
The upstream channel dug below the natural lake level has been filled. The final control elevation of 10445.5 was slightly higher than the old outlet and lower than we required during design. The breach is also slightly lower than the natural lake level, so this dam will be downgraded to a "No Hazard", Inactive structure on our inventory and we will cease our regularly scheduled dam inspections of this site. Water rights for the storage in Clements Lake must be moved down for storage in Big Sand Wash.

Clement's breach looking upstream.
