MIDDLE PROVO RIVER 2005 MONITORING REPORT

REPRESENTATIVE BEDLOAD SAMPLES DURING 2005 PEAK FLOWS AT THE SEDIMENT TRANSPORT MONITORING BRIDGES.

NOVEMBER 2006

DARREN OLSEN
BIO-WEST, INC.
1063 WEST 1400 NORTH
LOGAN, UTAH 84321

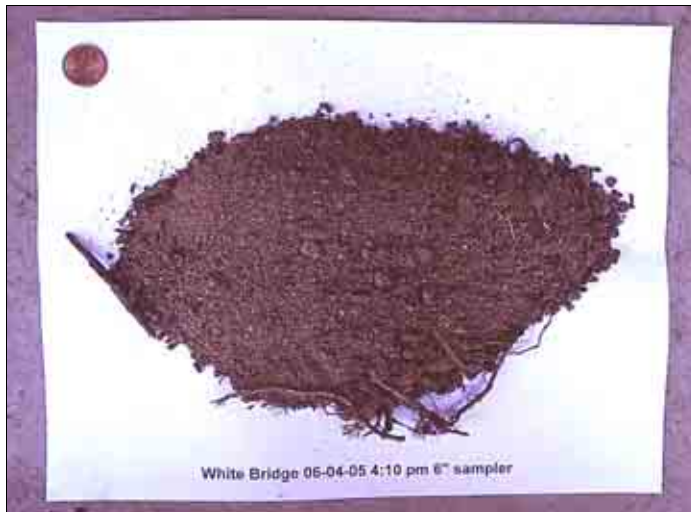
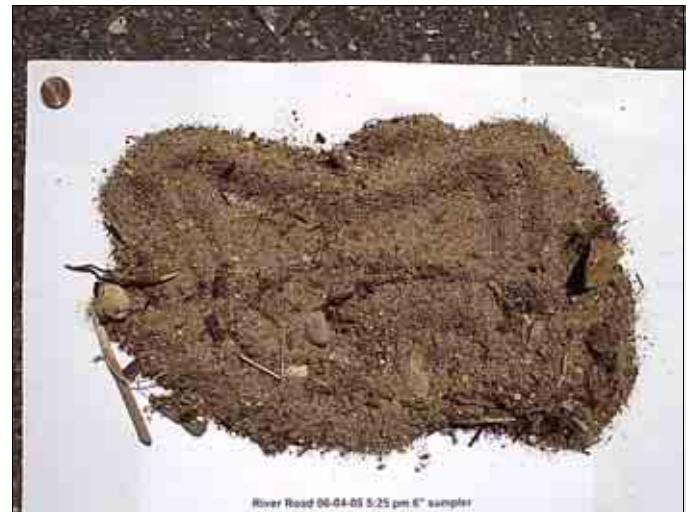
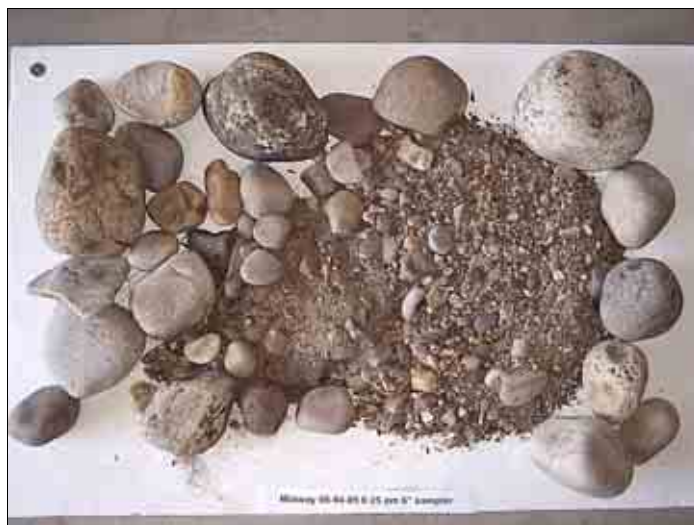
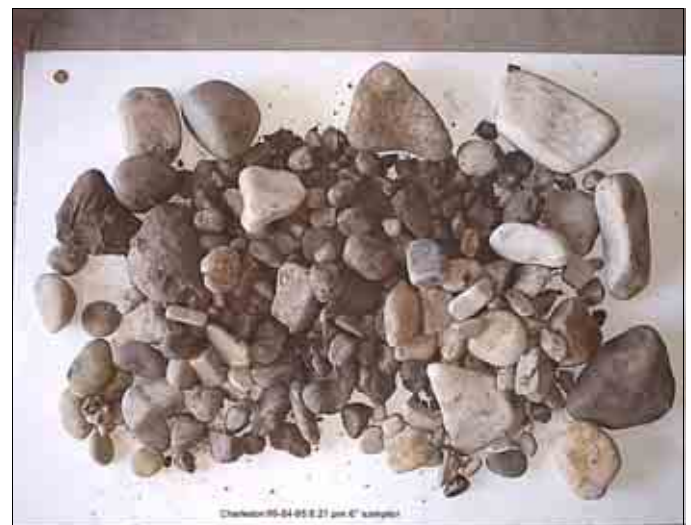
WHITE BRIDGE, 1.76 MILES BELOW JORDANELLE DAM.

RIVER ROAD, 4.18 MILES BELOW JORDANELLE DAM.

MIDWAY BRIDGE, 8.84 MILES BELOW JORDANELLE DAM.

CHARLESTON BRIDGE, 11.39 MILES BELOW JORDANELLE DAM.

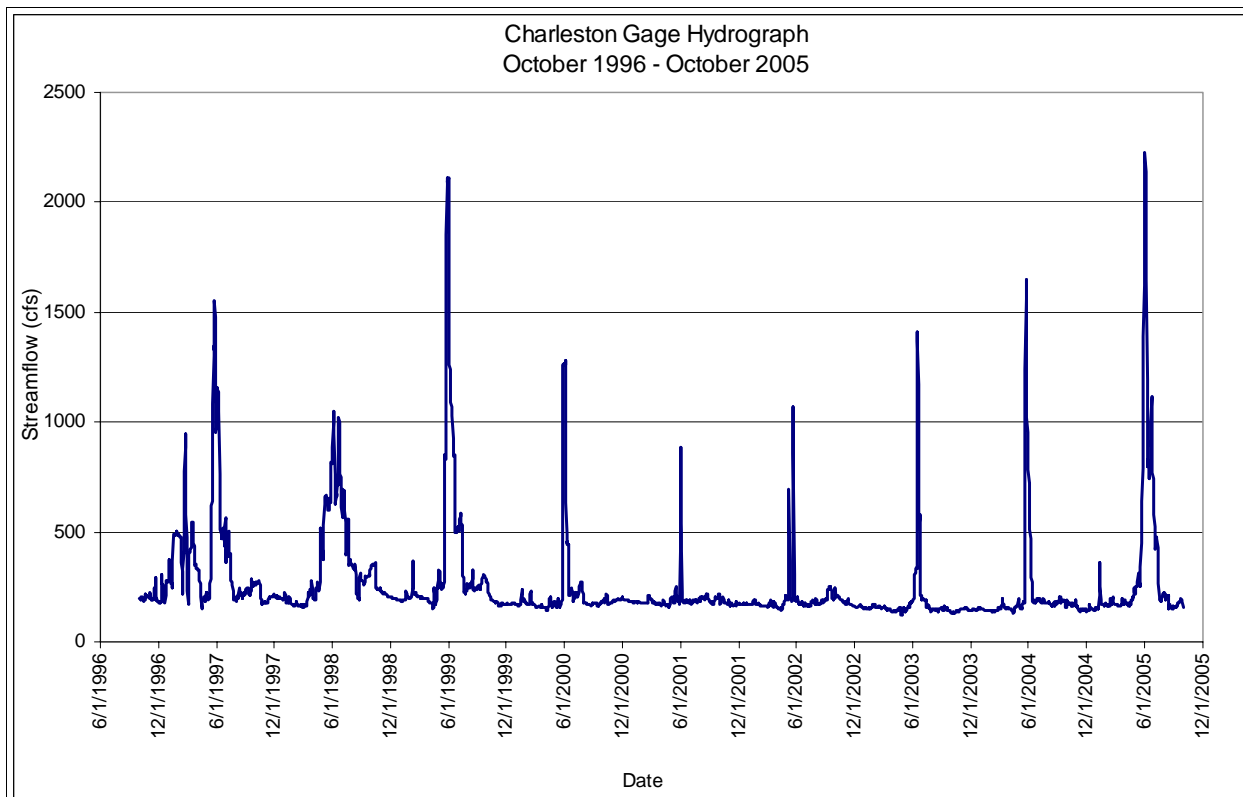
FIGURE 1.1. HYDROGRAPHS AND FLOW DURATION CURVES FOR ALL POST-JORDANELLE DAM WATER YEARS.

Many controls on the form and function of the middle Provo River may individually or cumulatively cause channel changes. The most obvious control on channel geometry is the magnitude and duration of peak flows. The flow duration curves indicate that only peak flows generally exceed 1,000 cubic feet per second (cfs). Peak flows have increased each year since the low peak in 2000. Peak flow in 2005 were much higher than any year since Jordanelle Dam closed in 1996. The 2006 monitoring should show the effects of these flows on cross sections and substrate at the monitoring sites (Figure 1.1).

An initial set of cross sections and longitudinal profiles were established in 2004 and re-surveyed in 2005 following a relatively high runoff year (Figure 1.1) in four reaches of the middle Provo River in order to establish a baseline and monitor change in channel geometry and slope over time. These data can be used in hydraulic modeling and other analyses that will be the basis for flow recommendations and other adaptive maintenance activities. Such recommendations and activities will assist the Mitigation Commission in maintaining desirable conditions for the middle Provo River and its floodplain. Monitoring data can also be used to show that the Mitigation Commission is meeting all fish, wildlife, and recreation mitigation commitments.

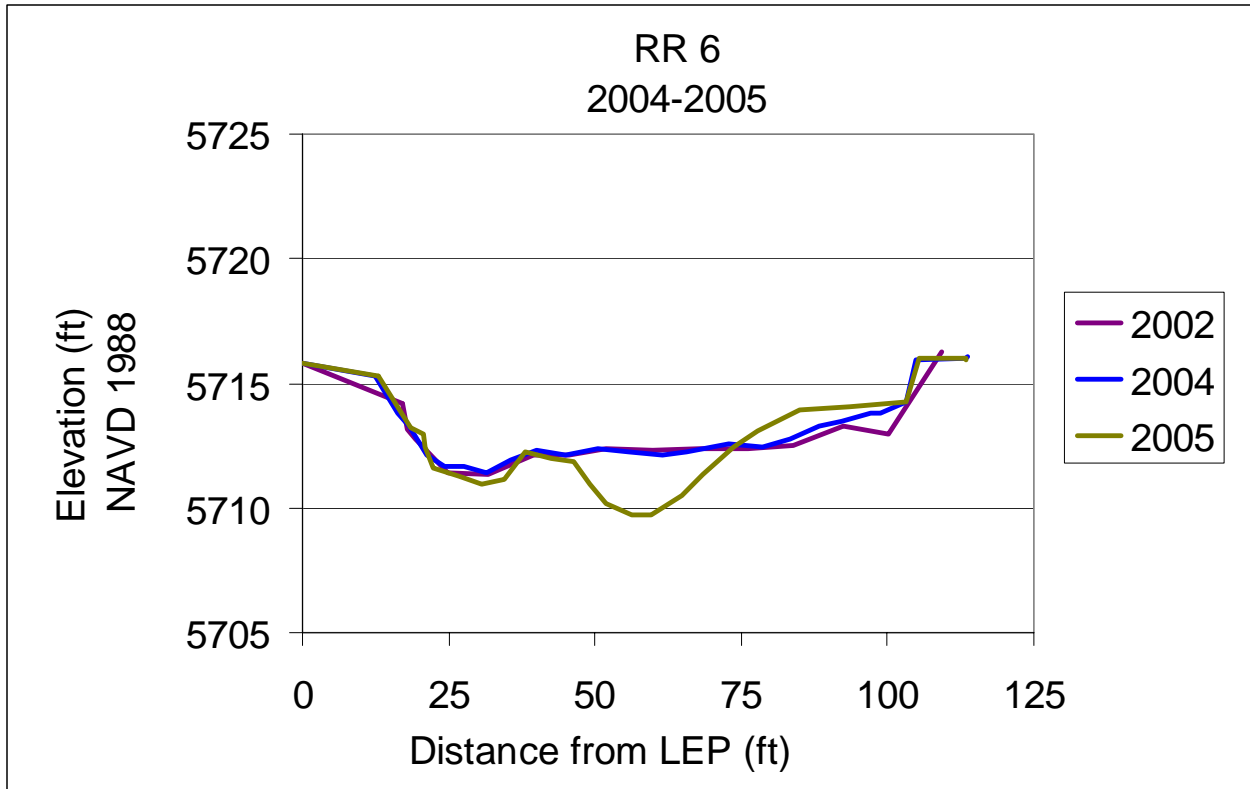
Transect RR6 was placed in the same location as a previously surveyed transect (Study Site 8, cross section 1) that was established as part of the 2002 field work for the Provo River Flow Study (Olsen et al. 2004). As seen in Figure 2.3, some changes in channel shape are evident among the 2002, 2004, and 2005 surveys. Channel shape is influenced by the gravel deposit on the right side of the channel, which forces flow toward the middle of the channel, where it is becoming deeper. The channel on the right in 2004 remains a side channel in 2005.

FIGURE 2.3. RIVER ROAD (RR) TRANSECT 6 (MAY 2004 AND 2005 SURVEY) COMPARED WITH STUDY SITE 8 CROSS SECTION 1 (MAY 2002 SURVEY).

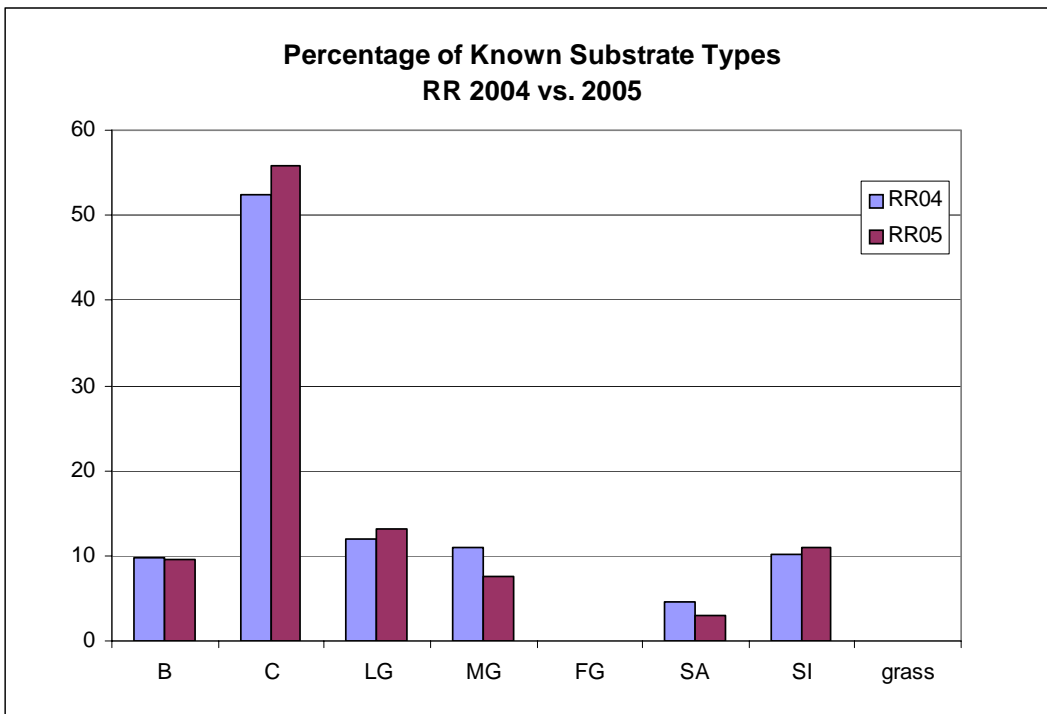
FIGURE 3.2B. COMPARISON OF AREA AT THE RIVER ROAD (RR) MONITORING SITE OCCUPIED BY VARIOUS SIZE CLASSES IN 2004 AND 2005.

Overall, changes in the substrate composition of the RR site between 2004 and 2005 were minor (Figure 3.1b, Figure 3.2b). Cobble remains the dominant substrate size at the site (Figure 3.3). Some changes in patch boundaries and composition were observed in the depositional area along the inside bend of the main channel near transect RR5 (Appendix 3.1a). This bar appears to have been aggrading slightly and vegetating, and the distribution of individual sand and gravel-dominated patches has shifted somewhat. Another area of change occurred along the right bank near transect RR6. The gravel deposit that increased in size between 2002 and 2004 (Olsen 2005) continued to

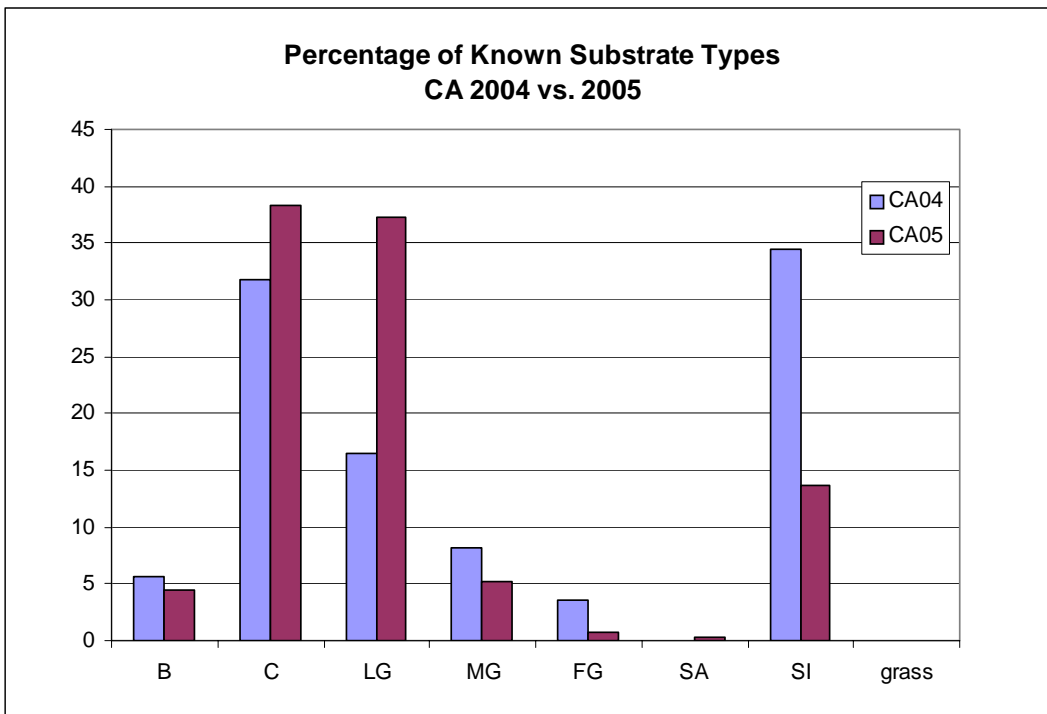
FIGURE 3.2D. COMPARISON OF AREA AT THE CHARLESTON (CA) MONITORING SITE OCCUPIED BY VARIOUS SIZE CLASSES IN 2004 AND 2005.

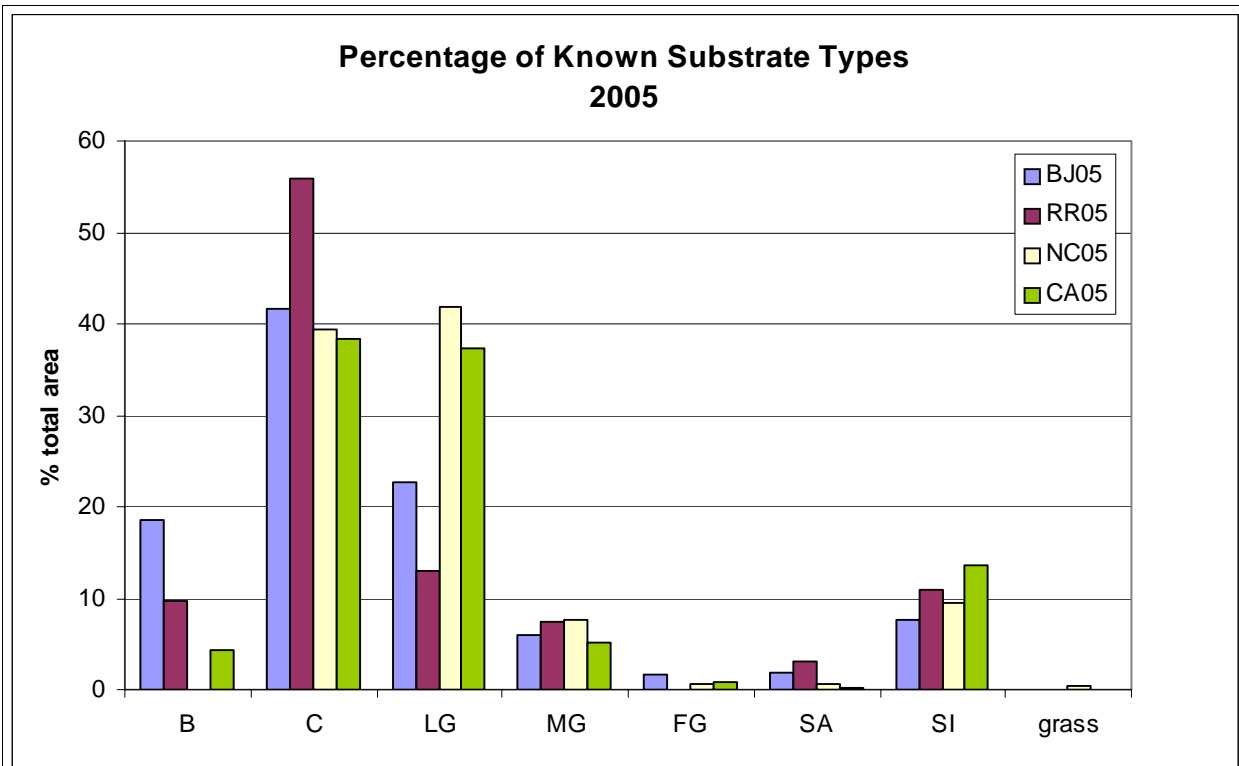
FIGURE 3.4. COMPARISON OF AREA OCCUPIED BY VARIOUS SIZE CLASSES AT EACH MONITORING SITE IN 2004 AND 2005.

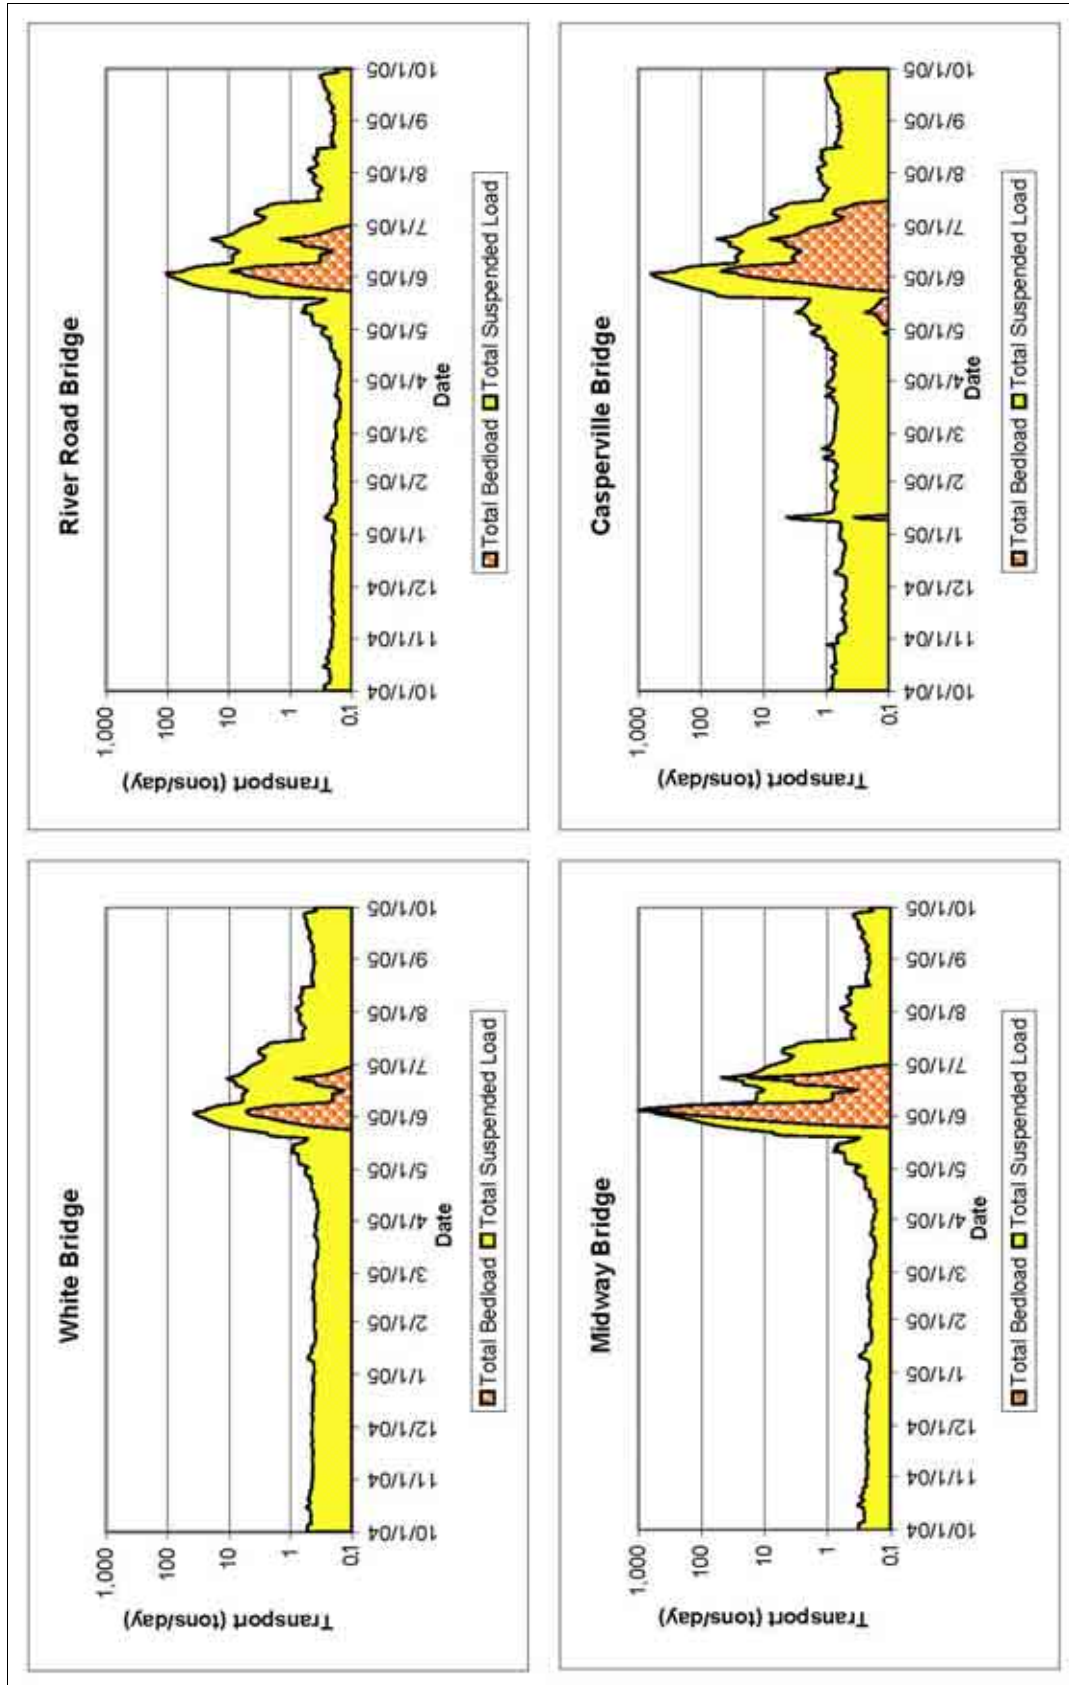
FIGURE 4.2. SUSPENDED (SOLID YELLOW) AND BEDLOAD (ORANGE DOTS) SEDIMENT TRANSPORT DURING THE 2005 WATER YEAR BASED ON USGS FLOW RECORDS AND EMPIRICALLY DERIVED RATING CURVES SHOWN IN APPENDIX 4.1. TOTAL TRANSPORT RATES ARE DRIVEN BY THE PEAK SPRING RUNOFF PERIOD, WHICH INCREASE IN THE DOWNSTREAM DIRECTION.

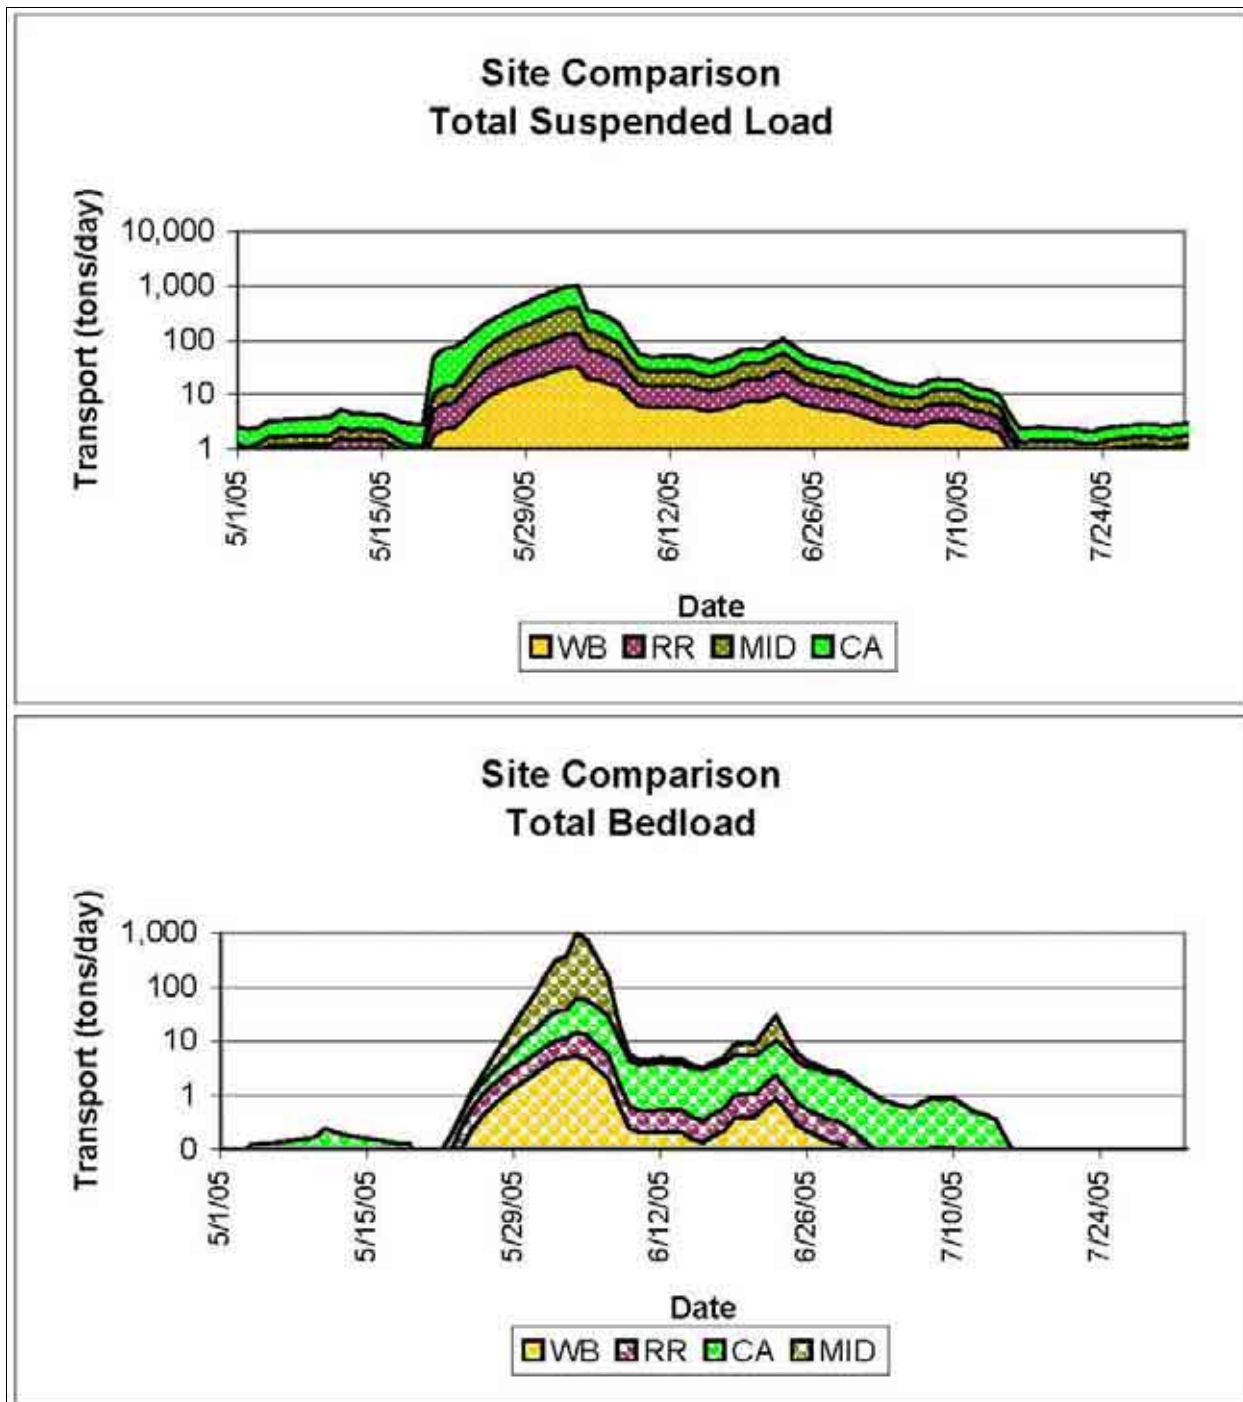
FIGURE 4.3. SEDIMENT TRANSPORT RATES IN THE MIDDLE PROVO RIVER DURING THE 2005 SPRING RUNOFF. THESE GRAPHS SHOW GREATER TRANSPORT AS DISTANCE INCREASES BELOW JORDANELLE DAM, EXCEPT FOR EXTREMELY HIGH BEDLOAD TRANSPORT AT THE MIDWAY (MID) MONITORING BRIDGE (BELOW THE NEVER-CHANNELIZED REACH).

A comparative graph of daily transport rates during spring runoff for all sediment monitoring sites (Figure 4.3) shows a distinct pattern of increasing suspended and bedload sediment transport rates with increasing distance below Jordanelle Dam, except for the aberration of bedload at the MID monitoring bridge (below the never-channelized reach). Peak flow bedload transport rates range

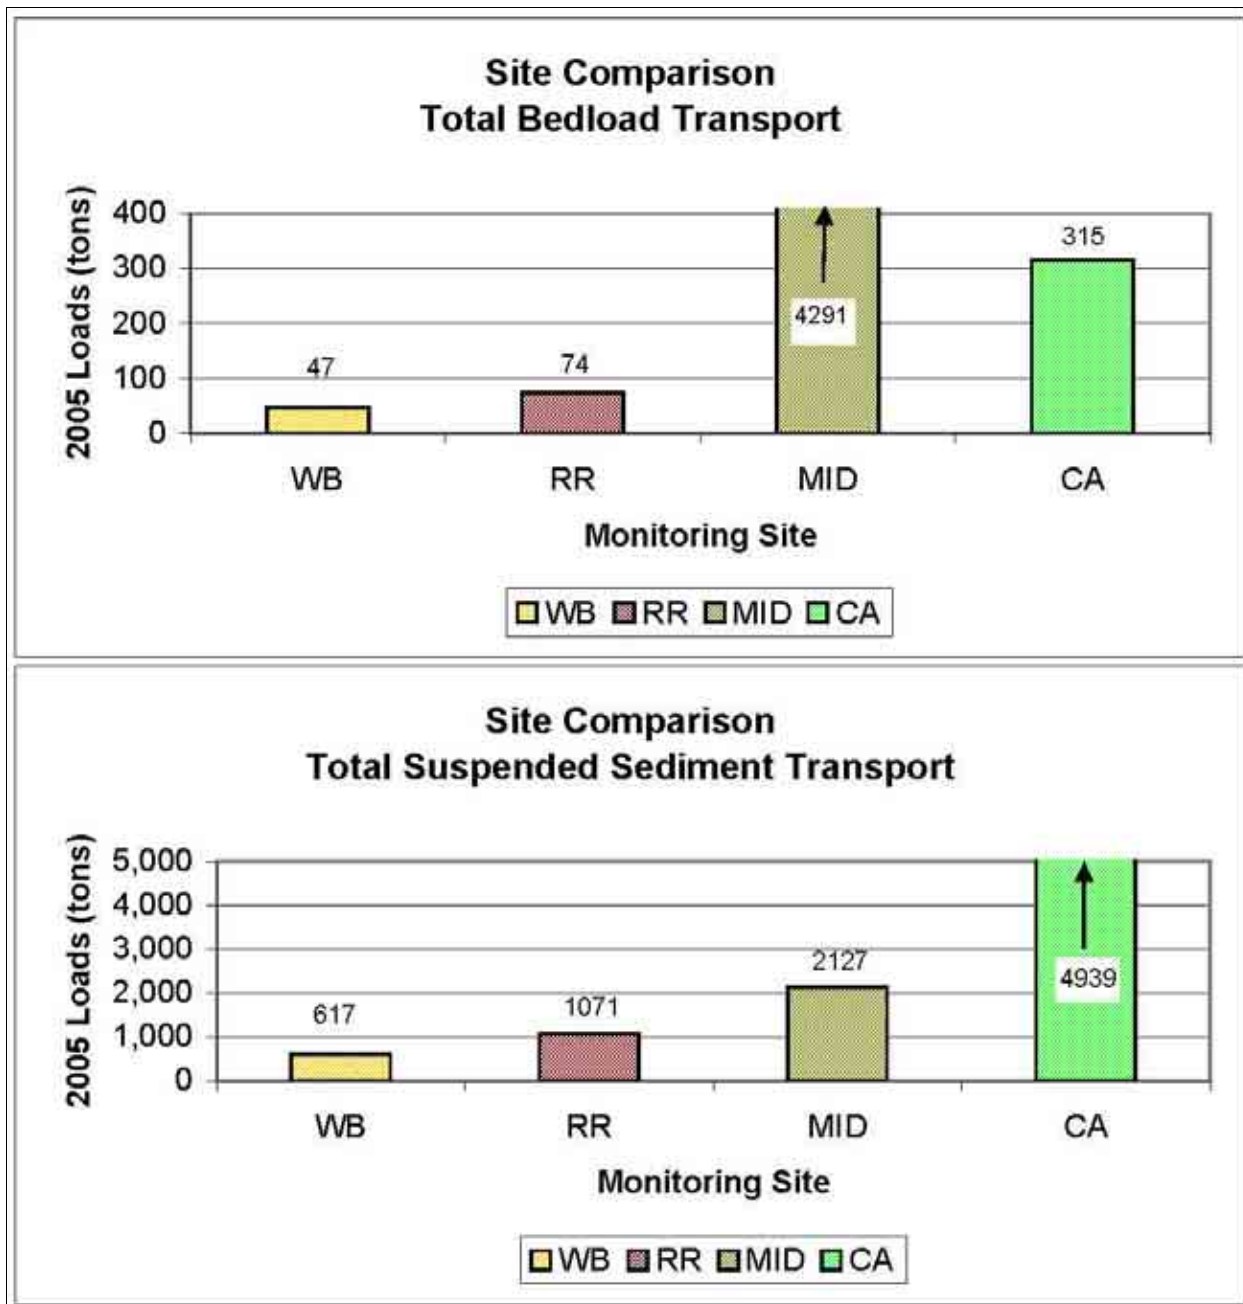
FIGURE 4.4. TOTAL ANNUAL LOADS IN THE MIDDLE PROVO RIVER DURING THE 2005 WATER YEAR. THESE GRAPHS SHOW INCREASING SEDIMENT LOADS WITH INCREASING DOWNSTREAM DISTANCE FROM JORDANELLE DAM, WITH THE EXCEPTION OF EXTREMELY HIGH BEDLOADS AT THE MIDWAY (MID) MONITORING BRIDGE (BELOW THE NEVER-CHANNELIZED REACH).

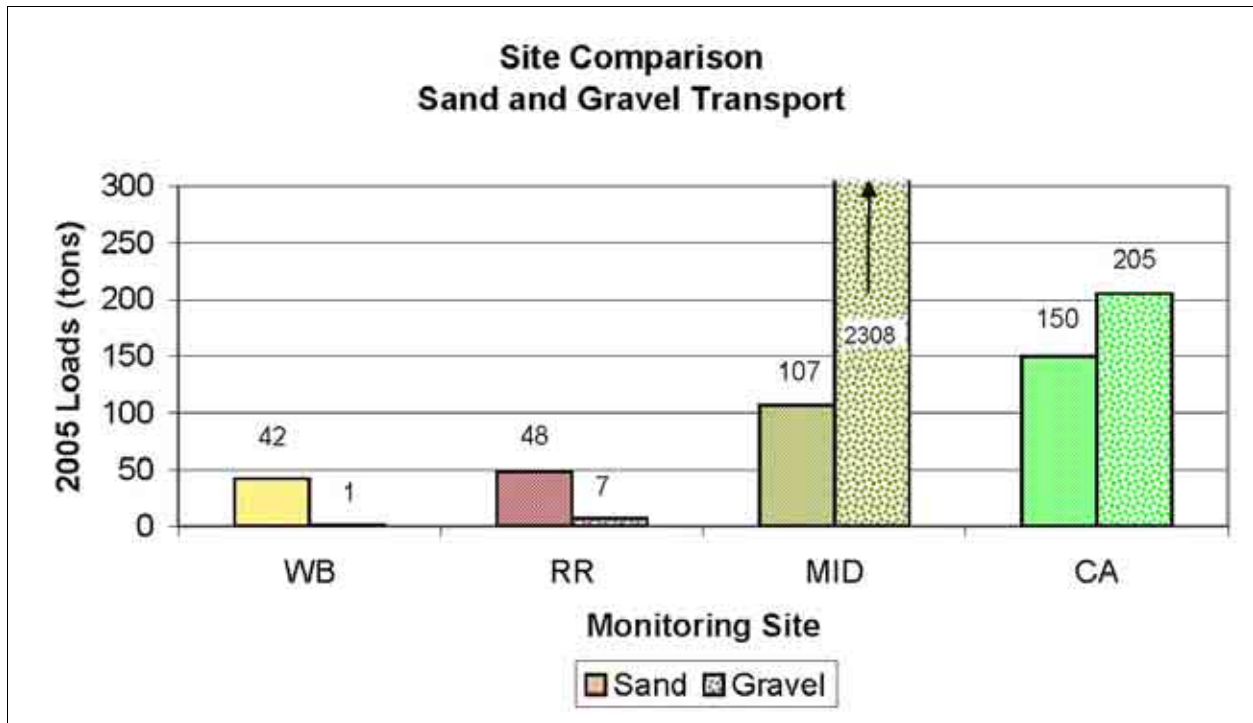
FIGURE 4.5. TOTALS AND GRAVEL LOADS IN THE MIDDLE PROVO RIVER DURING THE 2005 WATER YEAR. GRAVEL LOADS ARE EXTREMELY LOW (ALMOST NONEXISTENT) AT THE WB AND RR MONITORING BRIDGES, YET EXTREMELY HIGH AT THE MIDWAY (MID) MONITORING BRIDGE (BELOW THE NEVER-CHANNELIZED REACH). GRAVEL LOADS RETURN TO EXPECTED LEVELS AT THE CA MONITORING BRIDGE, APPROXIMATELY 2.5 MILES BELOW THE MID MONITORING BRIDGE.

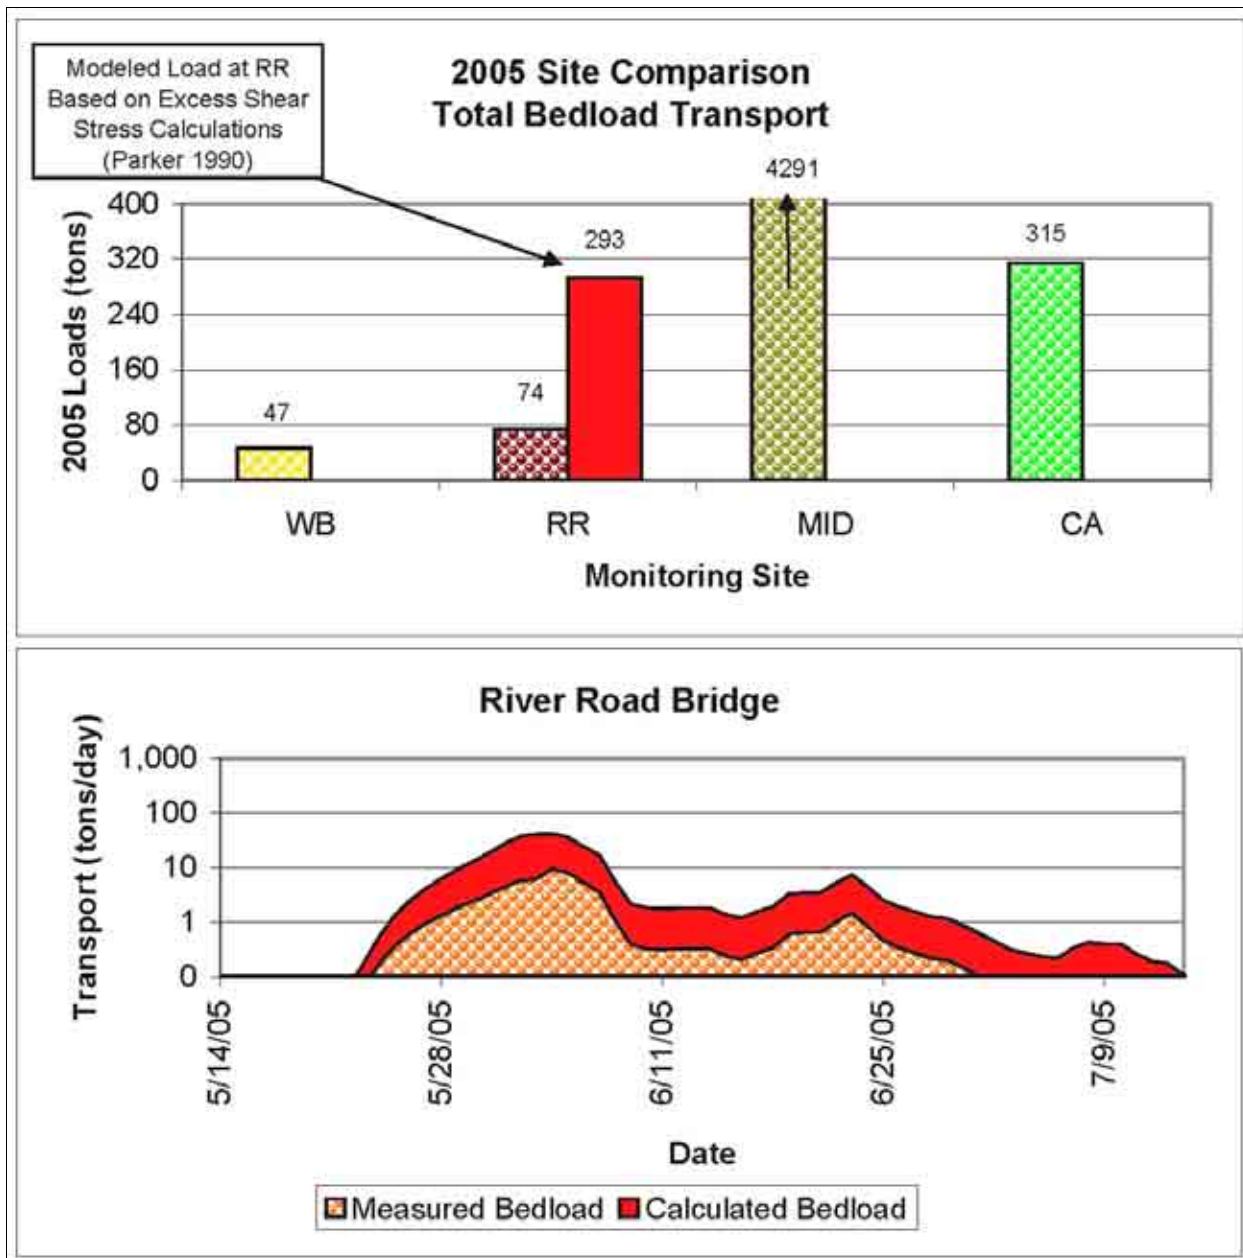
FIGURE 4.6. MEASURED BEDLOAD TRANSPORT RATES AND TOTAL LOADS AT THE RIVER ROAD (RR) MONITORING SITE COMPARED TO MODELED TRANSPORT RATES AND LOADS BASED ON PARKER'S (1990) BEDLOAD EQUATION FOR THE 2005 HYDROGRAPH. THE LOWER GRAPH SHOWS THE CALCULATED DAILY TRANSPORT RATES WHEREAS THE UPPER GRAPH SHOWS THE CALCULATED DAILY TRANSPORT RATES SUMMED FOR THE ENTIRE YEAR.
