High Mountain Lakes Stabilization Deer Lake Construction Report

Uinta Basin Replacement Project

November 2010

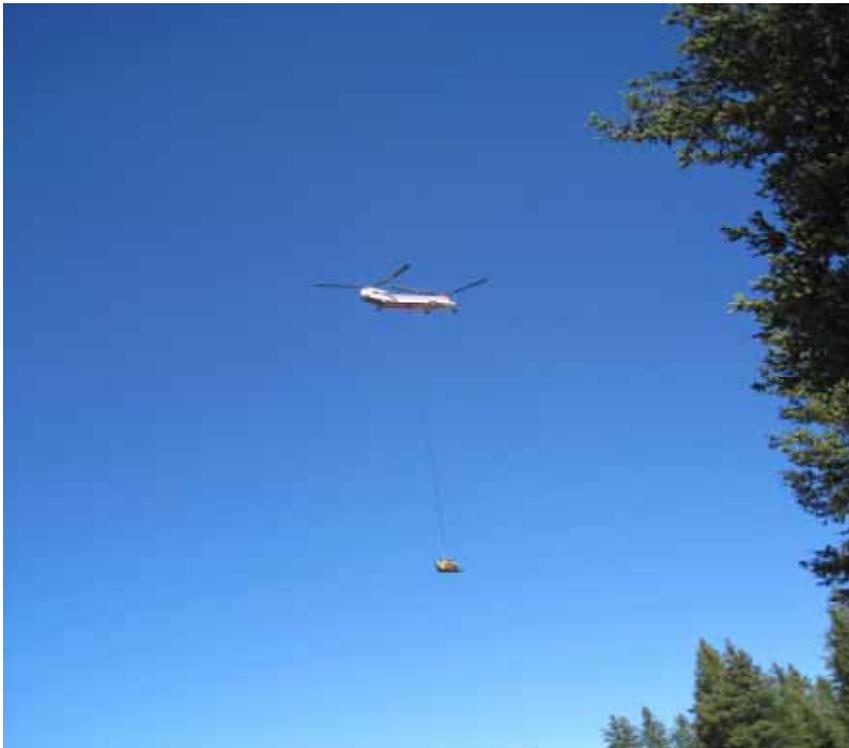
Figure 1: Columbia Helicopter flying equipment from Mill Park to Deer Lake.

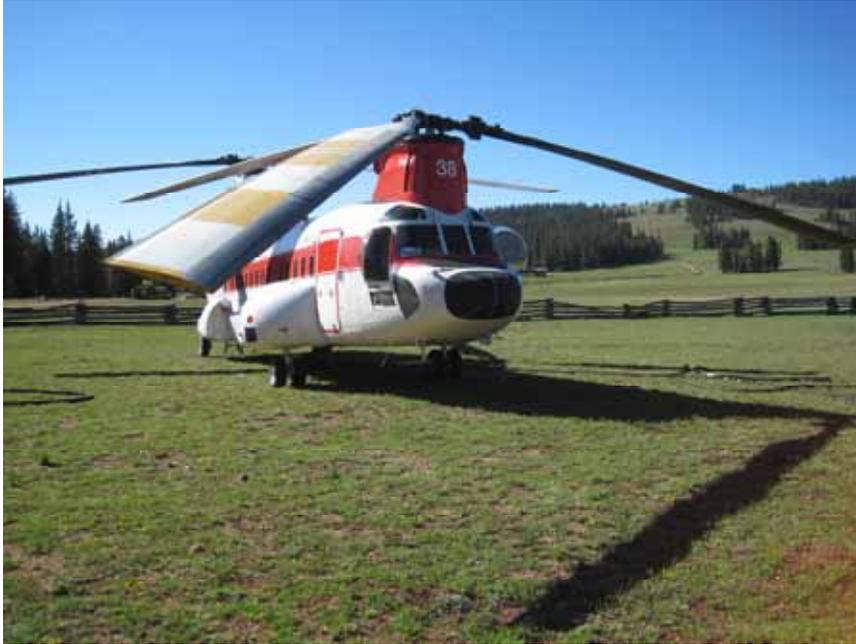
Figure 2: Helicopter used to transport equipment to worksite.

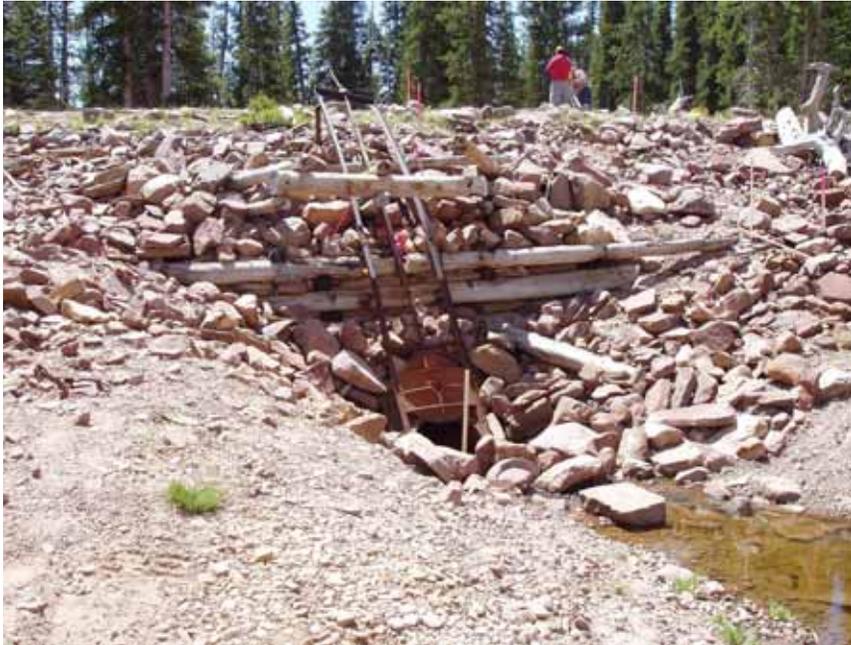
Figure 4: Deer Lake dam and head gate before removal.

As part of this project, the outlet works gate and pipe were completely removed and a stabilized outlet channel was constructed according to the design prepared by Reclamation engineers. Formal survey work was performed at Deer Lake and the contract record drawings are included in Appendix B of this document. The spillway elevation of the former reservoir was 10,226 feet. The stabilized outlet channel was set at elevation 10,218 to restore Deer Lake to close to the original natural lake level.

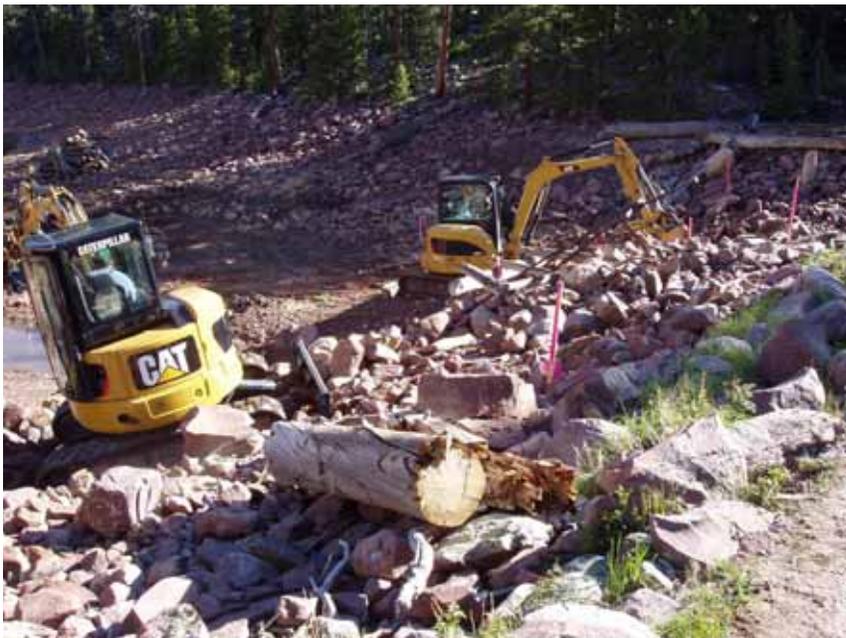
Figure 5: Reclamation crew using mini-excavators to remove riprap and cut breach through dam.

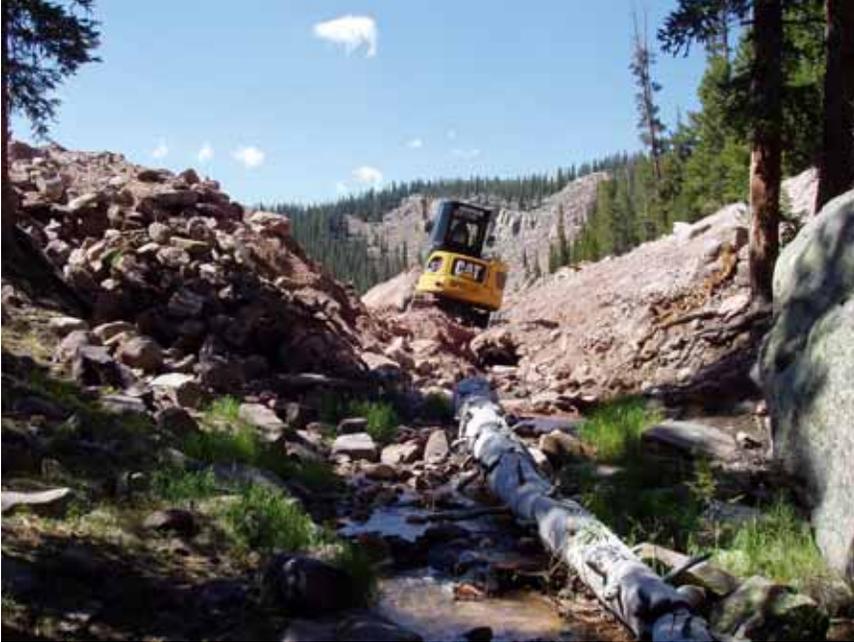
Figure 6: Crew continued cutting through Deer Lake dam – looking upstream.

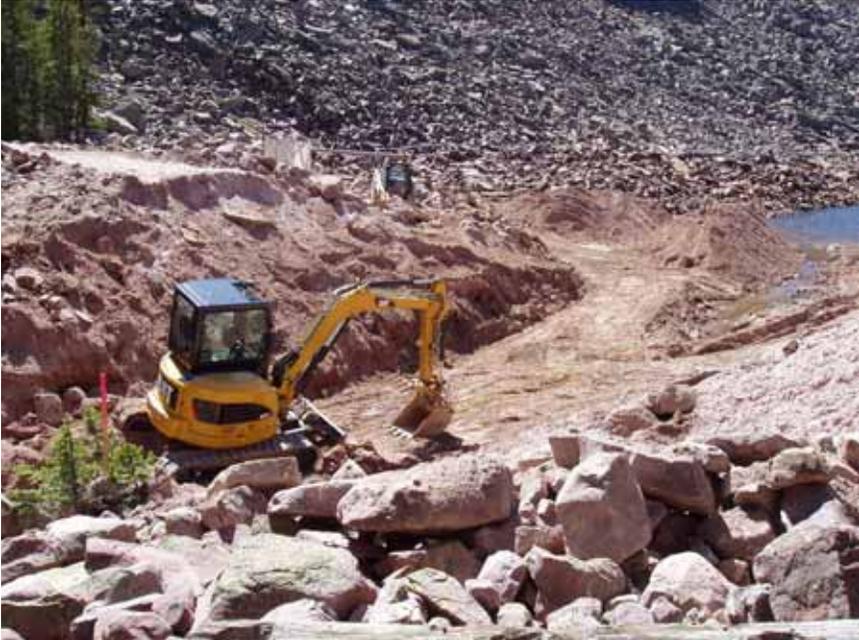
Figure 7: Crew excavating down to outlet pipe.

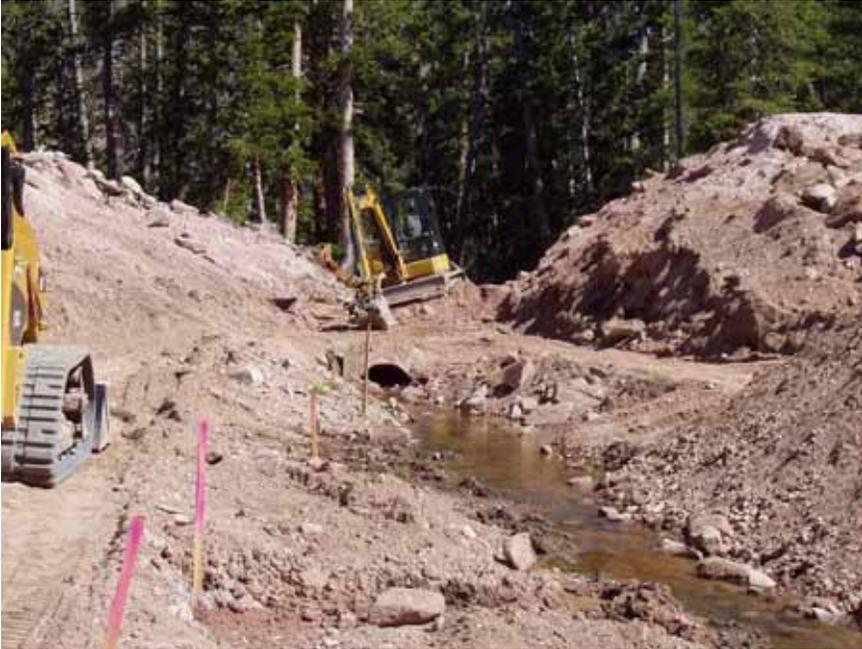
Figure 8: View of existing outlet pipe w/ breach cut through the dam.

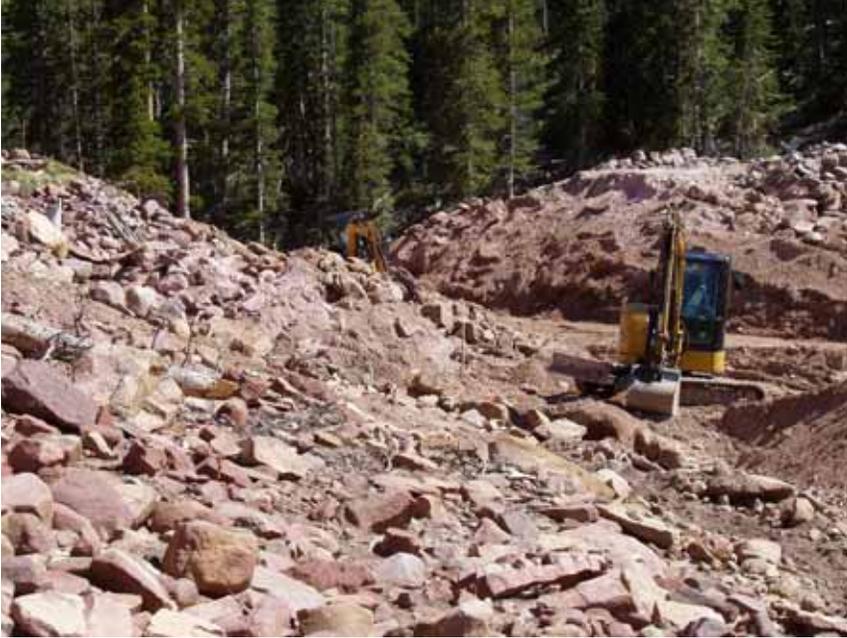
Figure 9: Crew using mini-excavator to cut through dam.

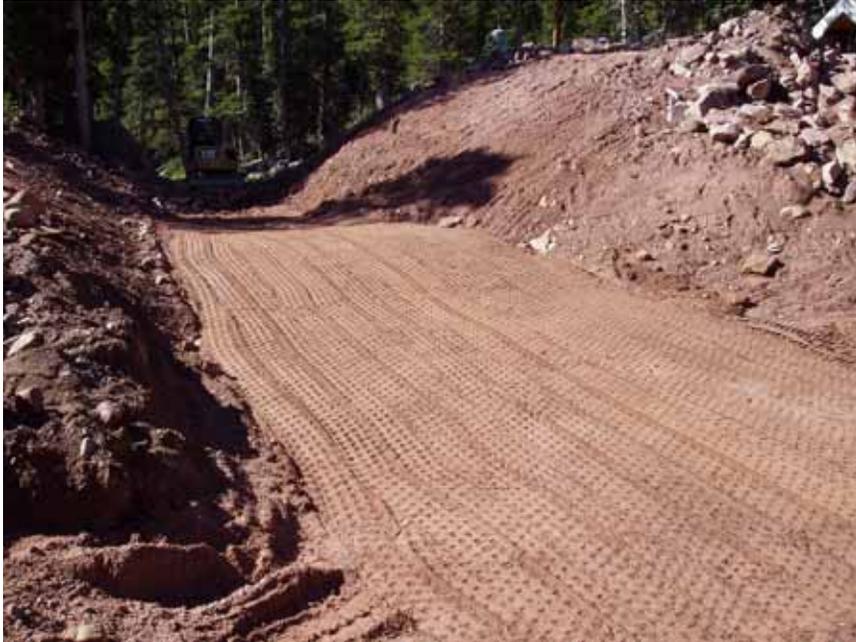
Figure 10: Looking downstream through the completed breach before riprap and rock sills were placed.

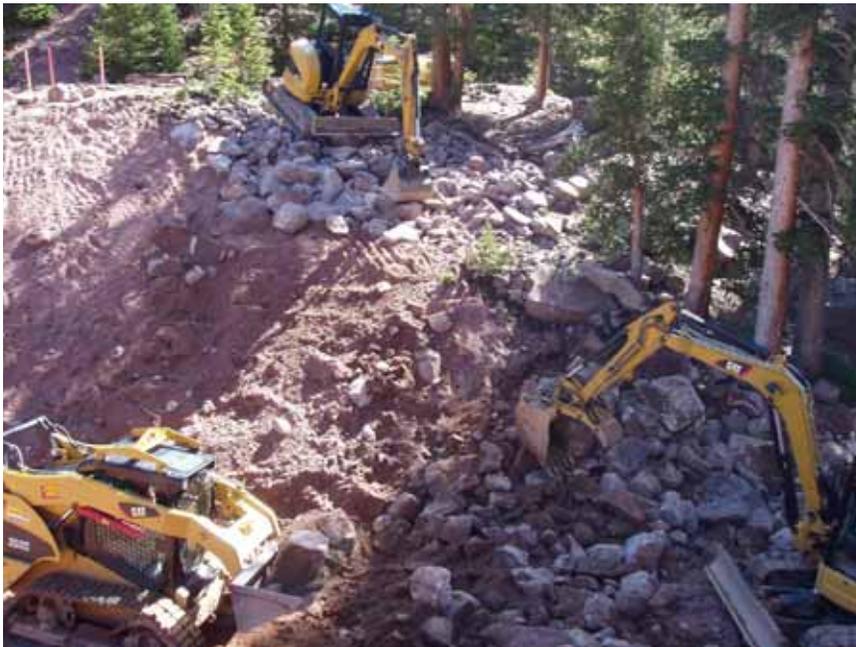
Figure 11: Reclamation crew placing riprap in breach.

The Reclamation crew placed riprap on the slopes and at the bottom of the breach and mixed in fines as they placed the rock sills at the design elevations and locations. One skidsteer was still broken so the crew did the work with 2 mini-excavators and one skidsteer. Valton asked the crew to put in a horse crossing at the head of the breach and the crew was able to accomplish that. On July 24th, one of the mini-excavators quit working; it had some electrical problems, so the crew was left with 2 pieces of equipment to finish up the work. The crew finished placing riprap throughout the entire breach and completed washing in fines at the bottom of the breach.

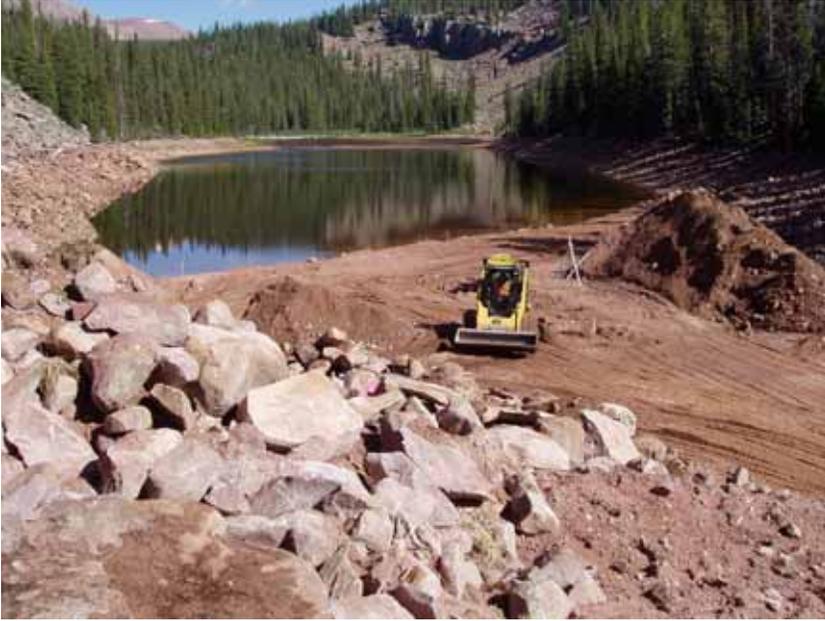
Figure 12: Looking upstream at the breach.

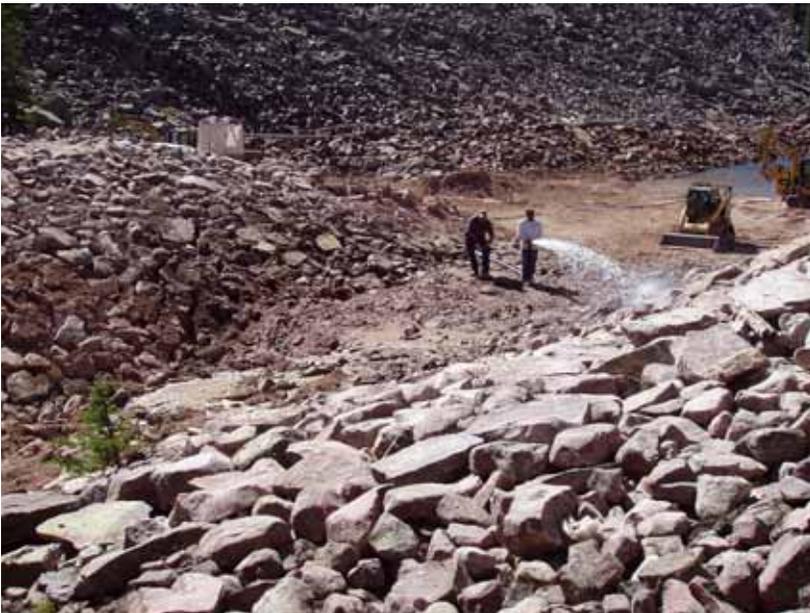
Figure 13: Crew washing fines into channel.

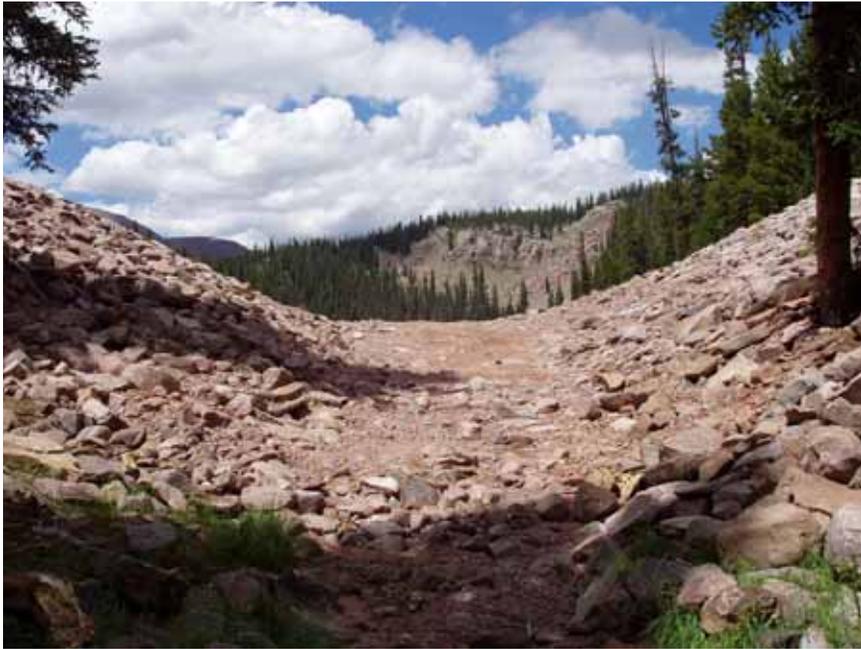
Figure 14: Looking upstream at the completed breach at Deer Lake.

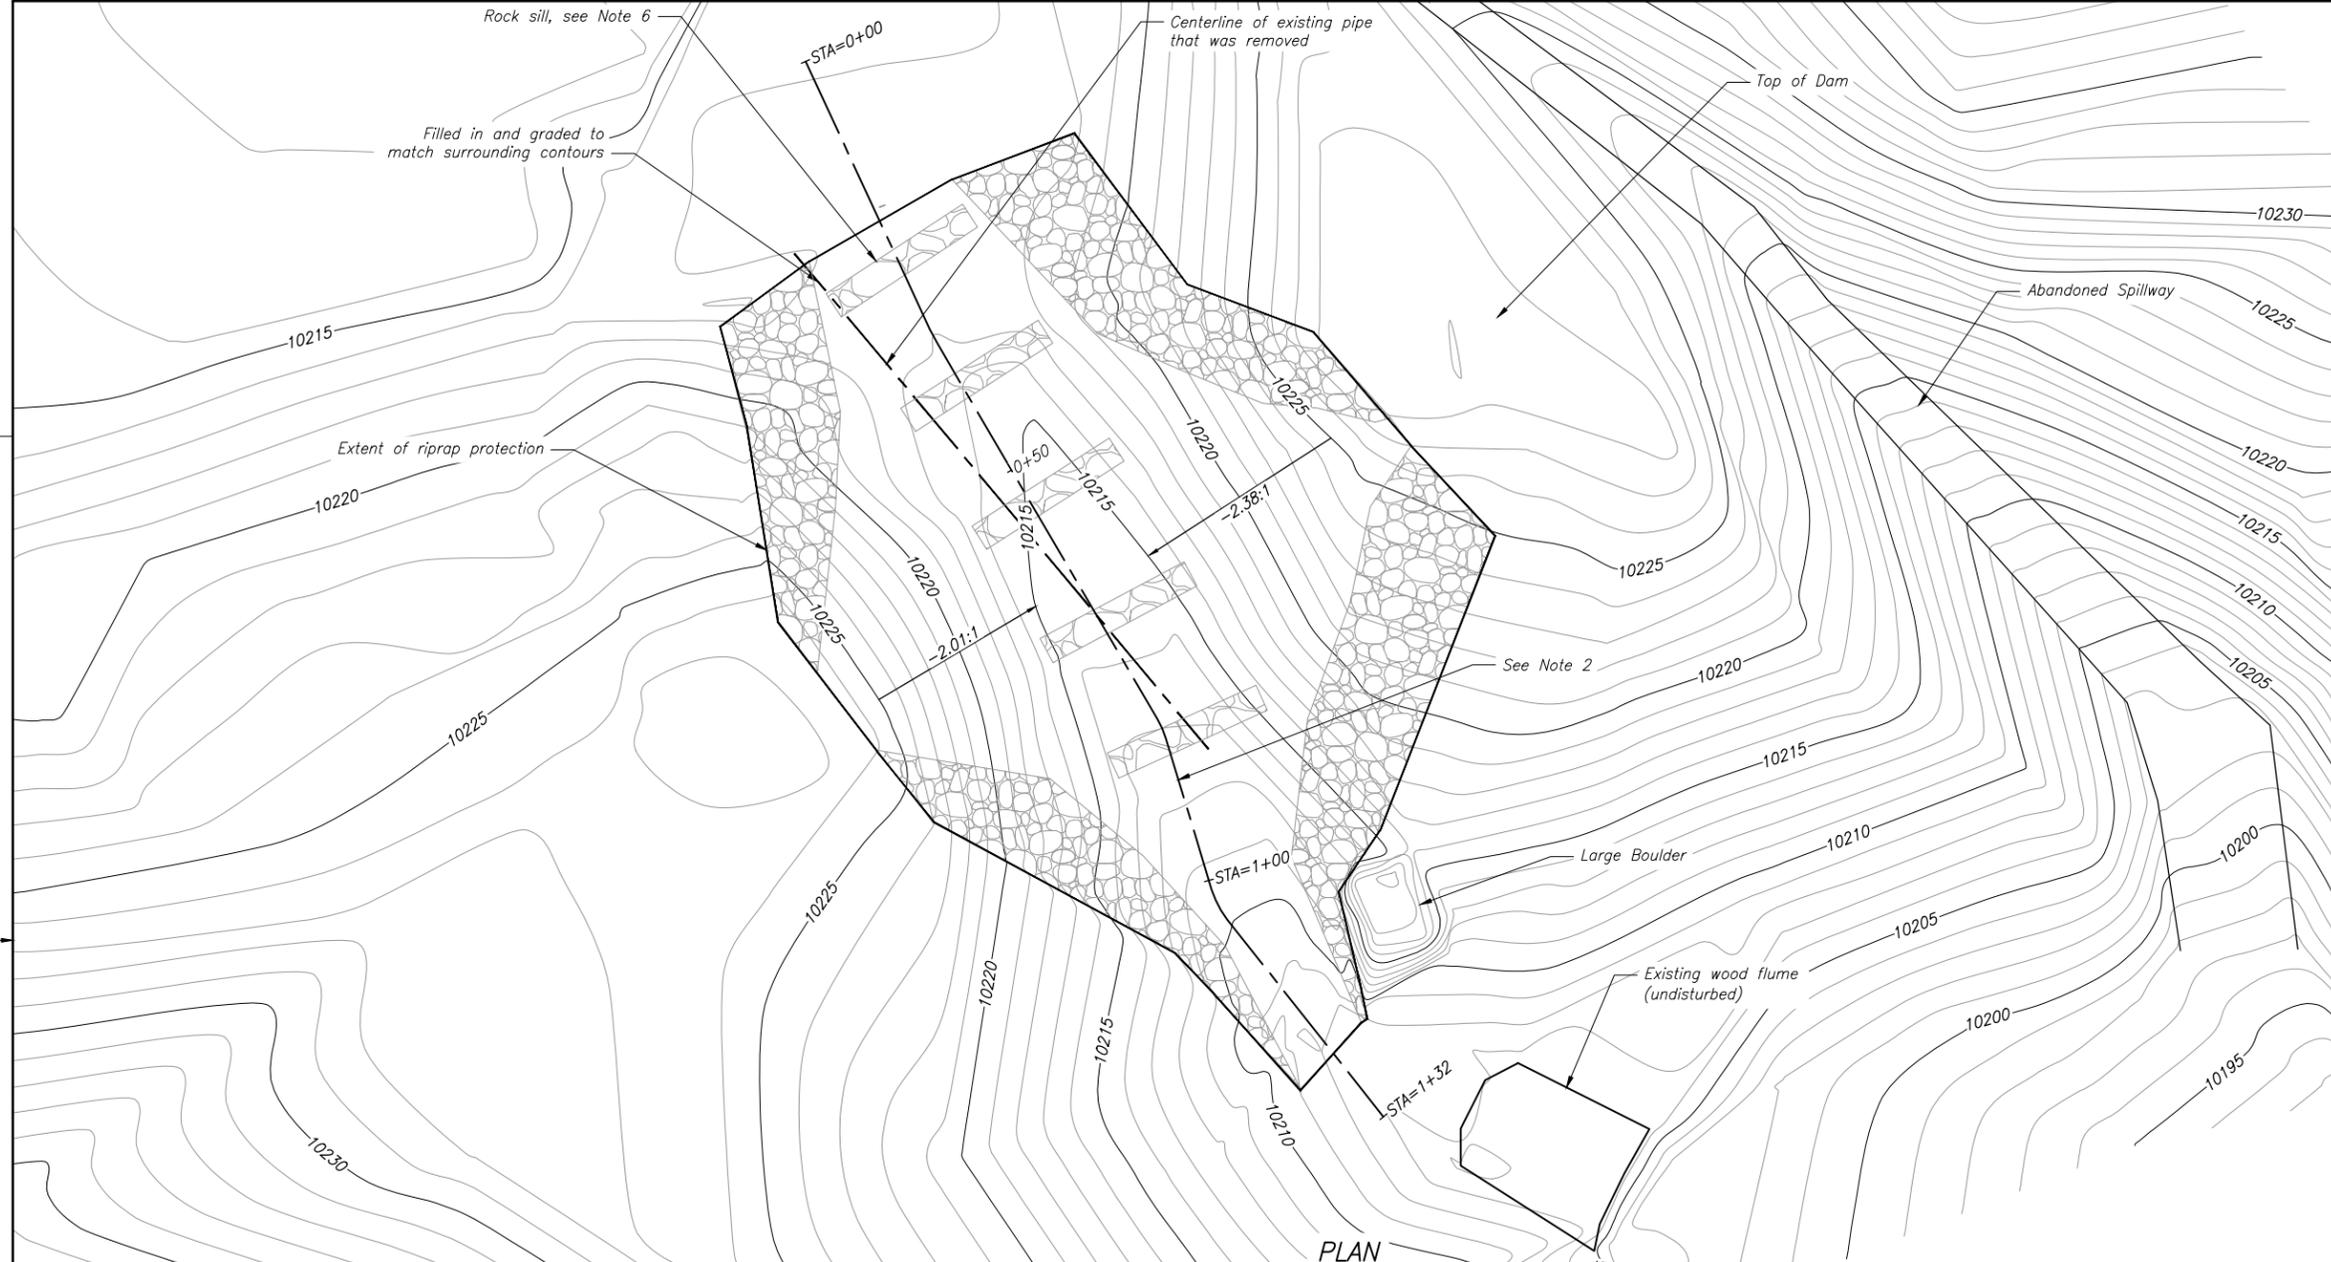
PLAN

1. Contour interval is 1 foot.
2. Centerline alignment varied along breach to create resting pools. During construction, breach centerline was rotated to avoid disturbing undisturbed soil.
3. Top of riprap El. 10,218. Cut vol. = 2,040 c.y.
4. Sand filter material mixed into riprap for 5 feet every 15 feet through breach.
5. Grid factor = 0.99949466
6. Rock sills are 24"-36" riprap intermixed with smaller rock to lock riprap together.
7. Backfill compacted to the extent possible based on tools allowed to be used. Backfill material is a matrix of 6"-12" rock mixed with fine soil.
