**Montes Creek Mitigation Site
As-Built Report**

**Uinta Basin Replacement Project
Big Sand Wash Reservoir Project
(Corps of Engineers Action ID Number: 200250319)**

**Prepared by
Allred Restoration, Inc.
August 2010**

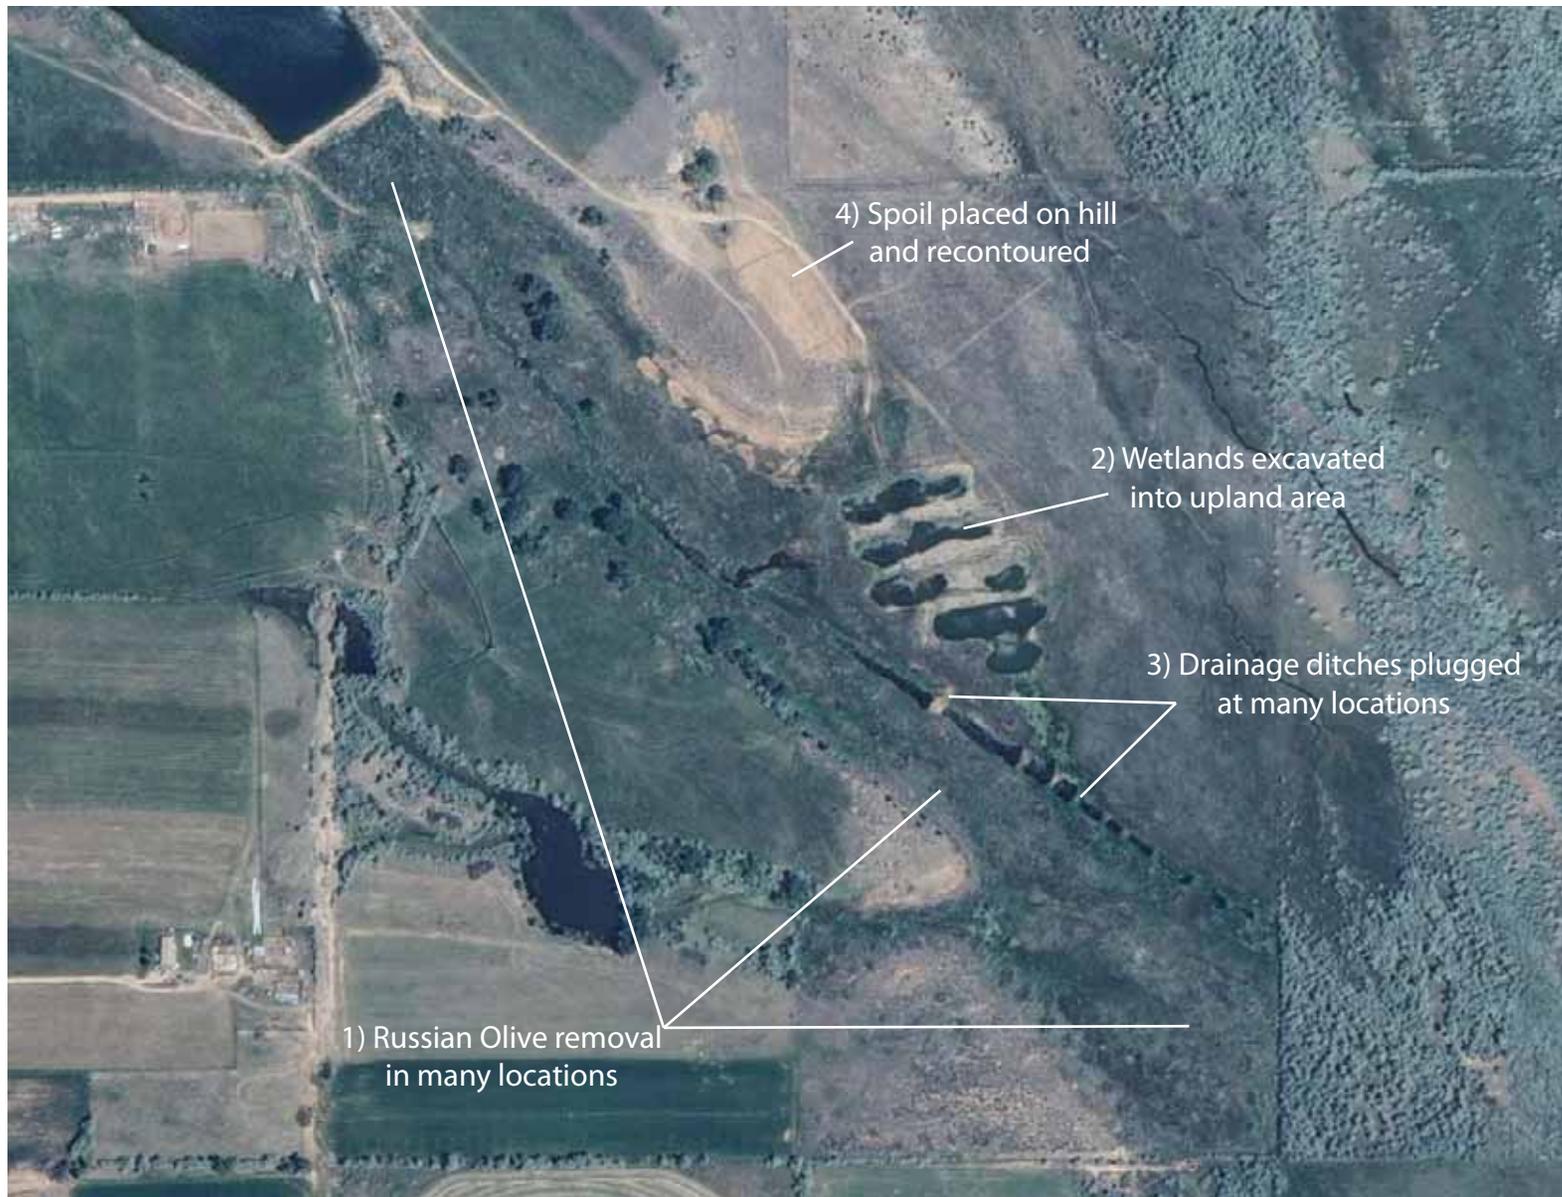
The selected alternative has been fully implemented, with very few adjustments and/or changes. A post-project, 2009 aerial image shows all the major components, which are labeled in Figure 9, including; (1) removal of Russian olive trees, (2) excavation of several large new wetlands in an upland area, (3) plugging of drainage ditches, and (4) placement of spoil material along the northeast slope of the northern bluff.

Figure 9. Aerial image of the mitigation site at the Montes Creek WMA, taken in 2009. The image shows several several of the main features that were constructed for the mitigation project.

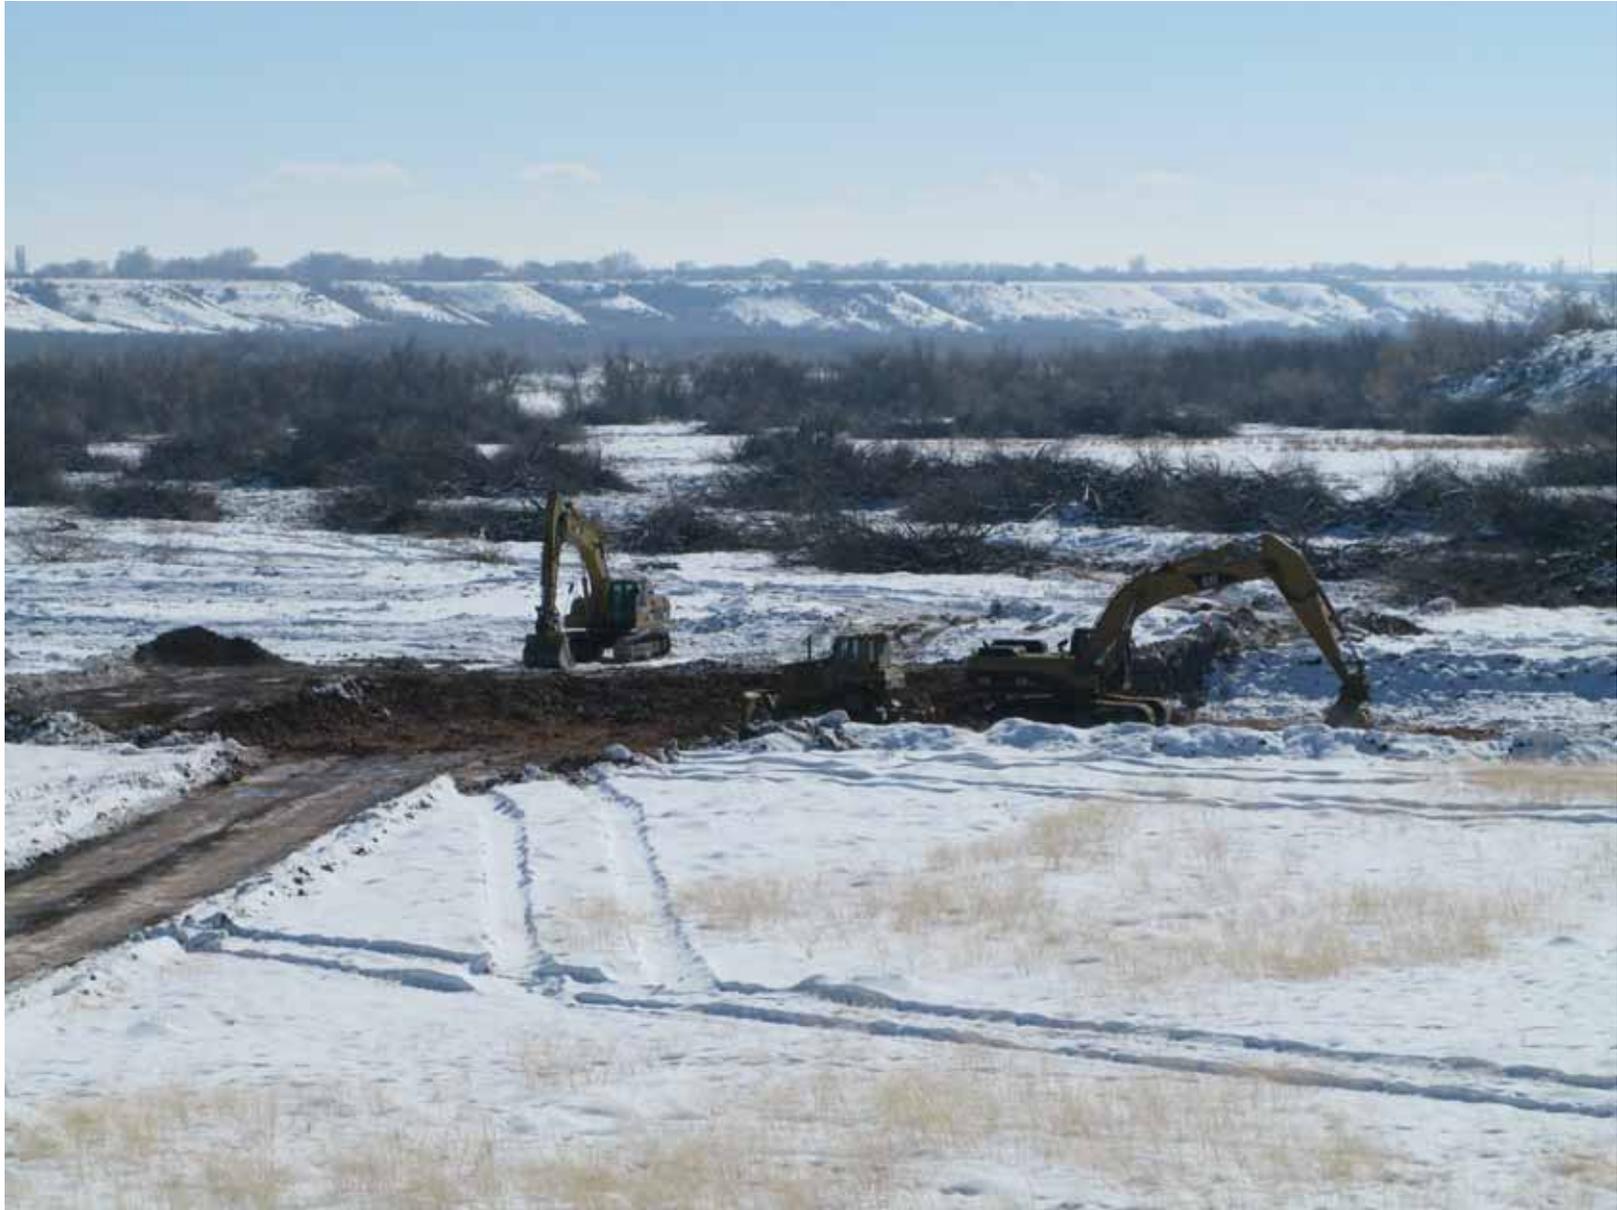
cut stumps with herbicide (Garlon-4); or 3) basal bark application of Garlon-4® to small stems. Figure 10 shows a portion of the WMA following Russian olive removal, with many large piles of trees that were subsequently burned.

Figure 10. Photograph of the mitigation site following removal of Russian Olive trees. The trees have been uprooted and placed into piles for subsequent burning. This image also shows the beginning of wetland excavation.

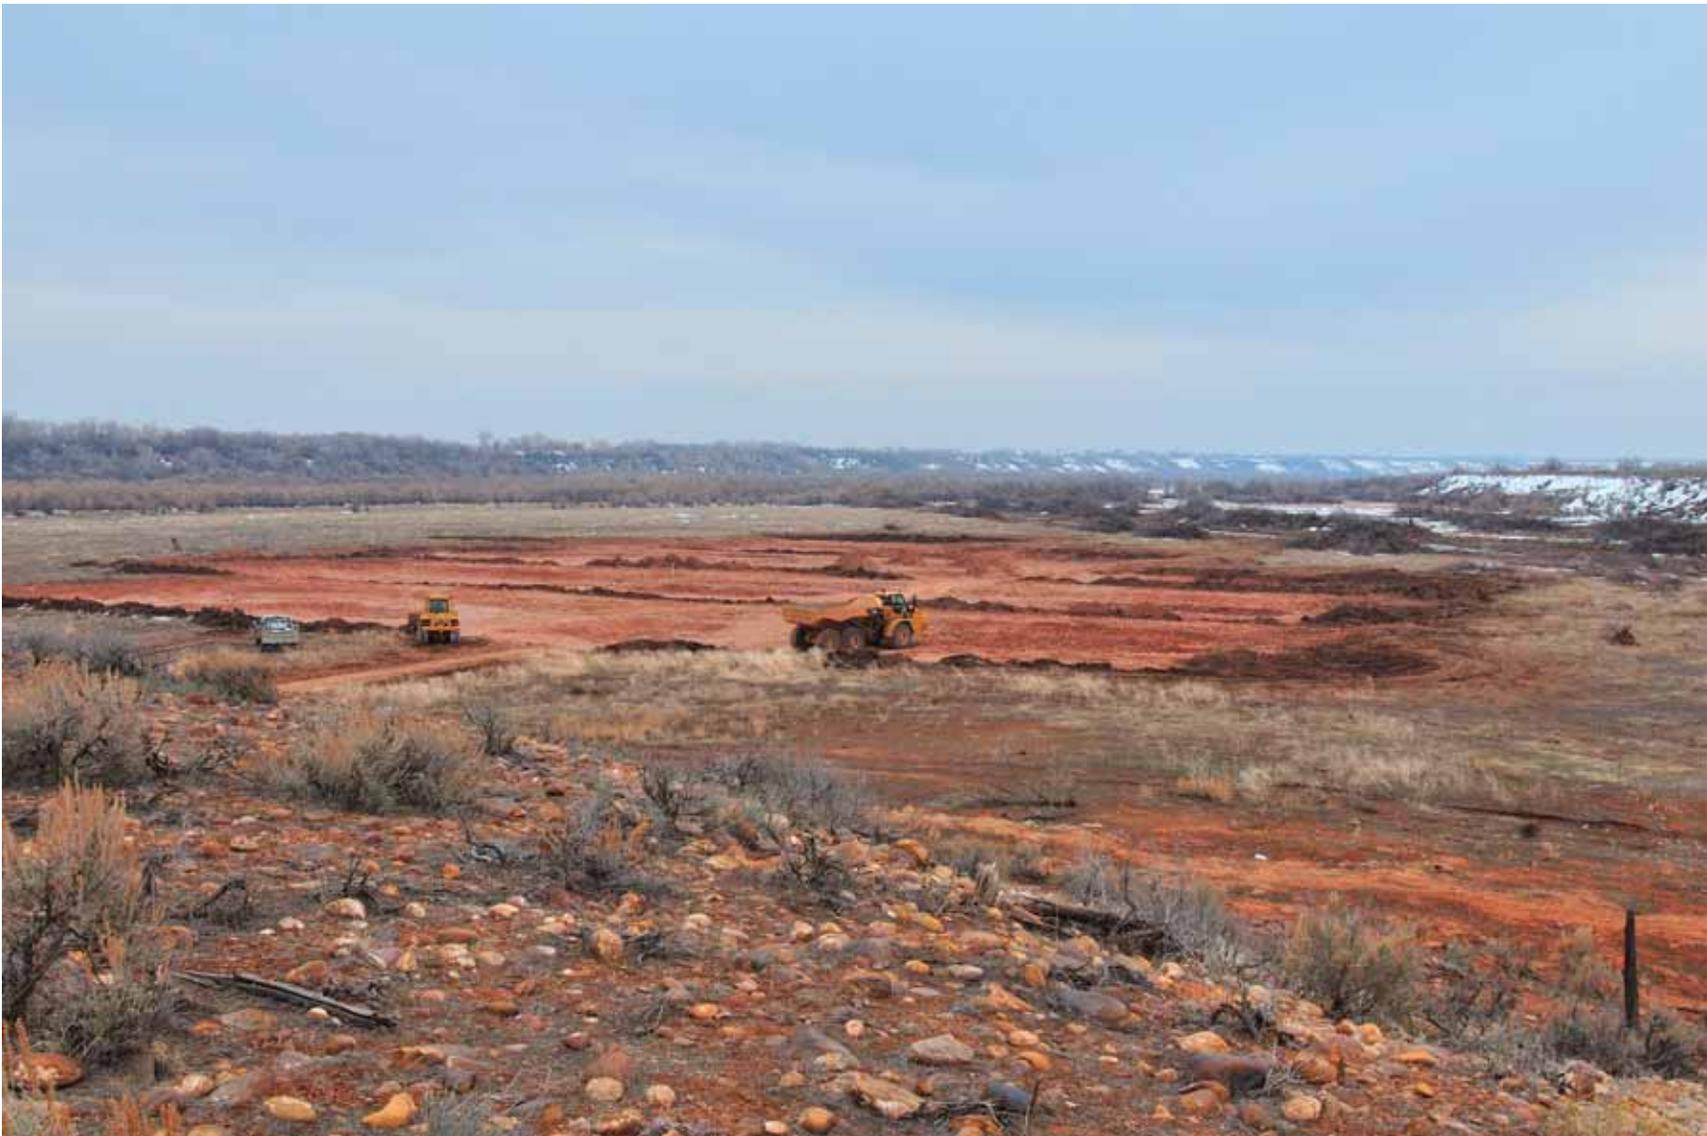
Excavation of the new wetlands began early in February of 2008, soon after removal of the Russian olive trees (see Figure 10). Temporary access roads were cleared of snow to allow the ground to freeze. The frozen ground allowed equipment to move freely around the site without sinking into the soil, although caution still was required when working in particularly wet areas. Wetland excavation proceeded rapidly, with the bulk of the earth moving completed by March, 2008 (Figure 11).

Figure 11. Photograph of the mitigation site taken in March 2008. The bulk of earth movement was mostly completed, but contouring, shaping, and topsoil application were still needed.

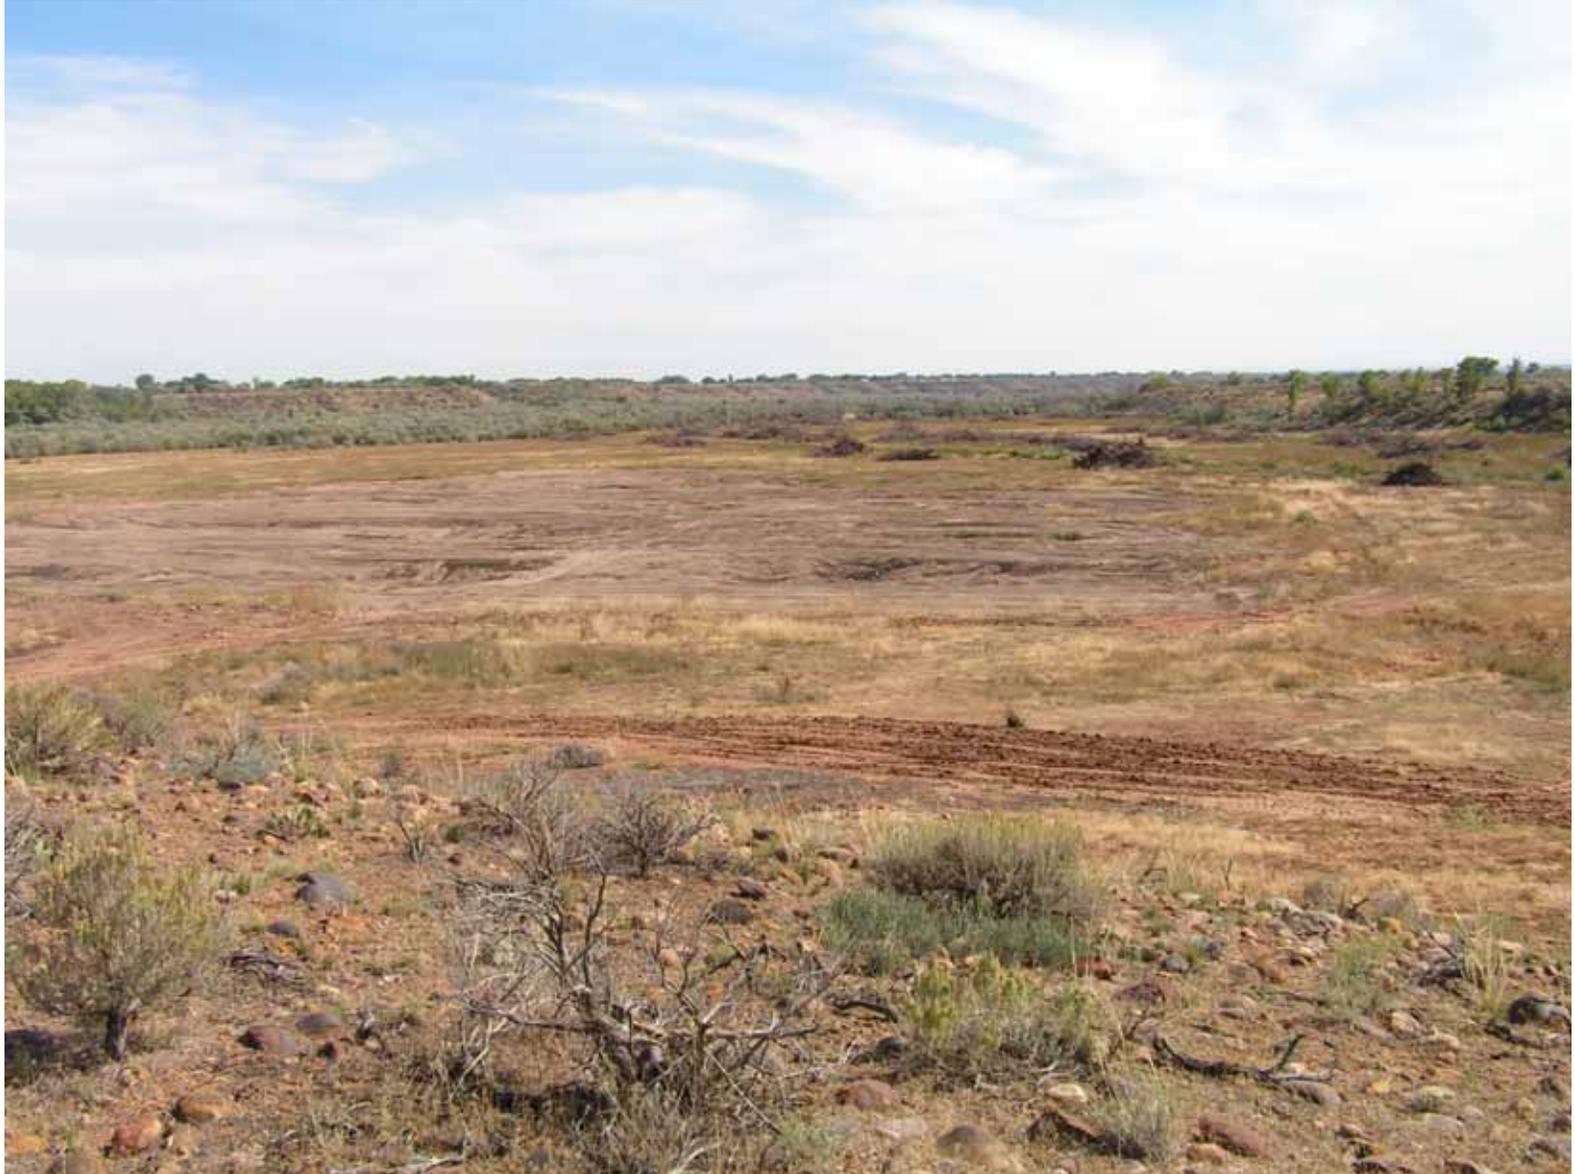
The soils around the constructed wetlands were quite sterile and needed some type of soil amendment to promote a healthy and viable wetland plant community. After excavating the land surface between the wetland ponds to the desired elevation, the soil was stripped an additional six inches and replaced with a comparable thickness of on-site excavated/recovered sand, amended with compost (Figure 12). Compost used for the project was Class A municipal waste compost from the Ashley Valley Sewer Management Board wastewater treatment plant located in Vernal, Utah. This topsoil mixture now provides a good growth medium for wetland plants.

Figure 12. Photograph of the newly-constructed wetlands after application of the topsoil mixture.

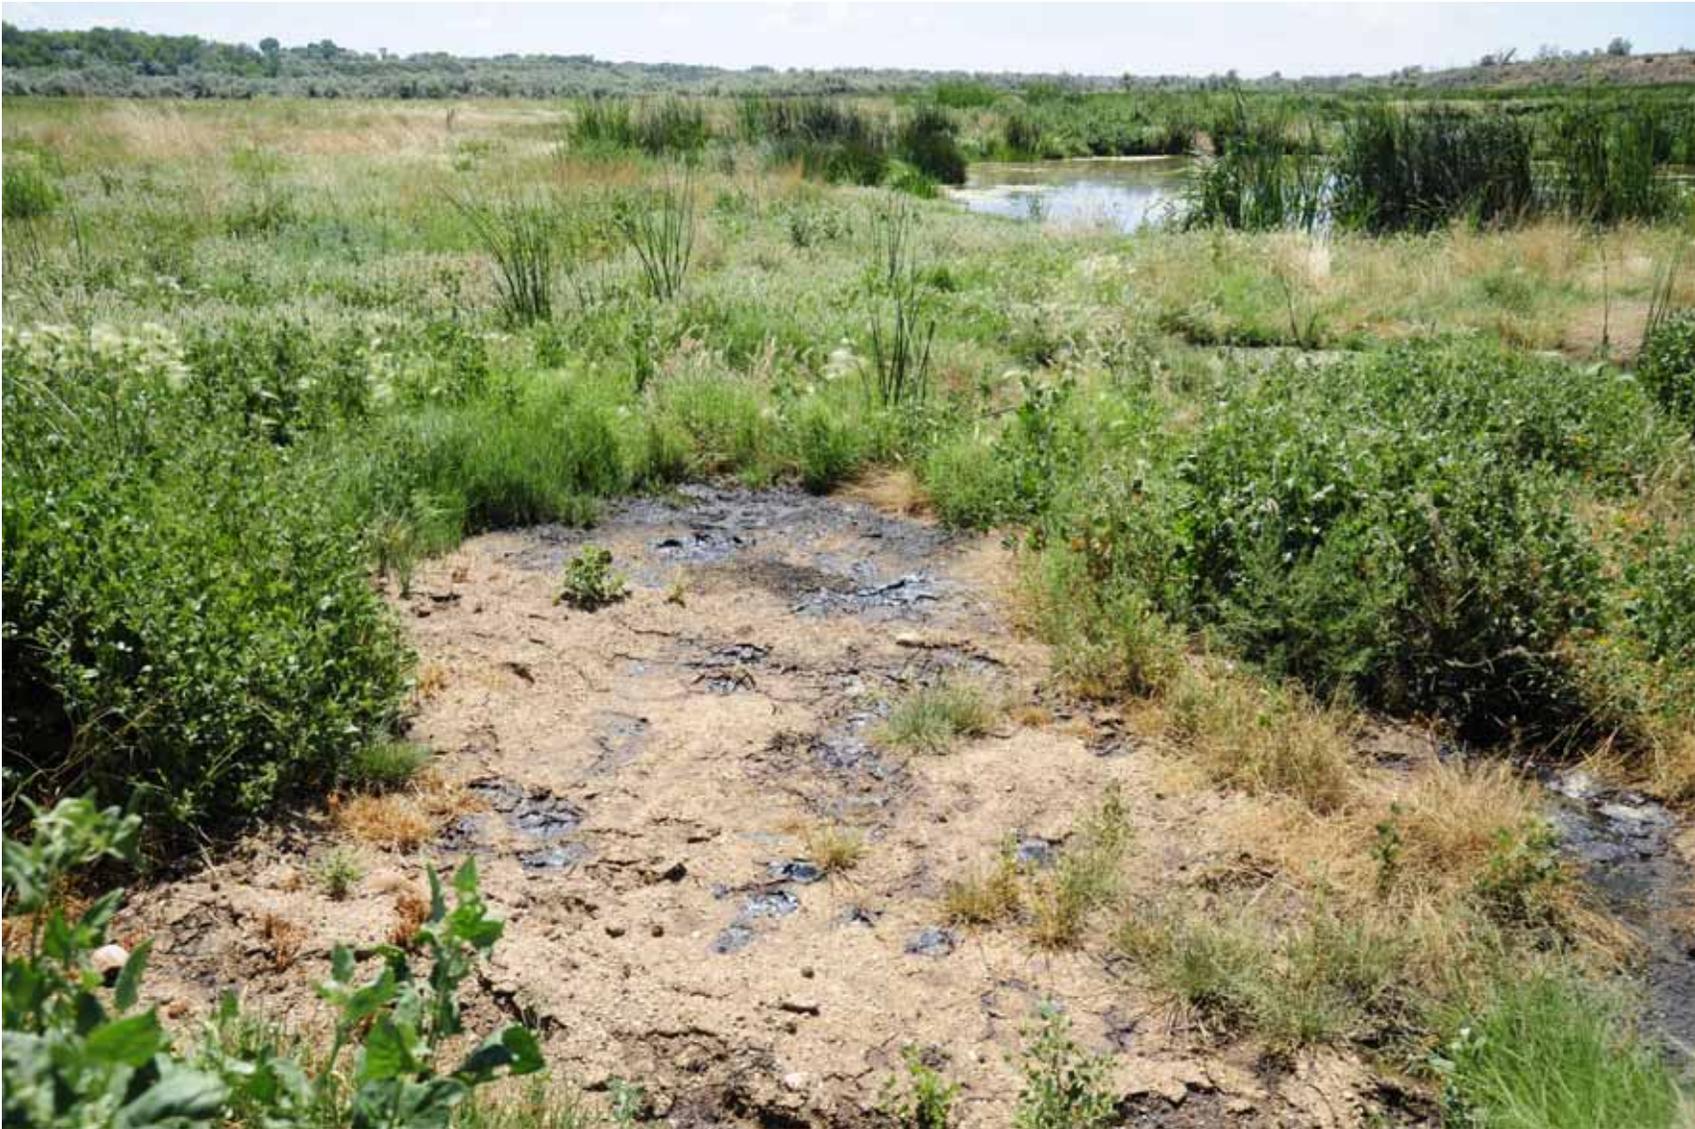
In some locations, the topsoil mixture appears to have been applied with bio-solids that were not completely cured. These composted waste products require a curing period to allow for complete breakdown of the waste material. Although most of the material appeared to be completely cured, there were some problem areas where the curing process was apparently not complete. These locations are referred to as “hot” areas, and they appear as black slicks with little or no plant growth. One of these hot areas is shown in Figure 13. The hot areas cover only a small proportion of the wetland area, and as such, are deemed to be a minor problem. Over time, the organics in the hot areas should break down and allow vegetation to grow normally.

Figure 13. Photograph of the mitigation site taken in 2010. The topsoil mixture had “hot” areas where breakdown of organic material was incomplete. The areas are visible in the photo as dark patches. Little vegetation has grown in those locations.

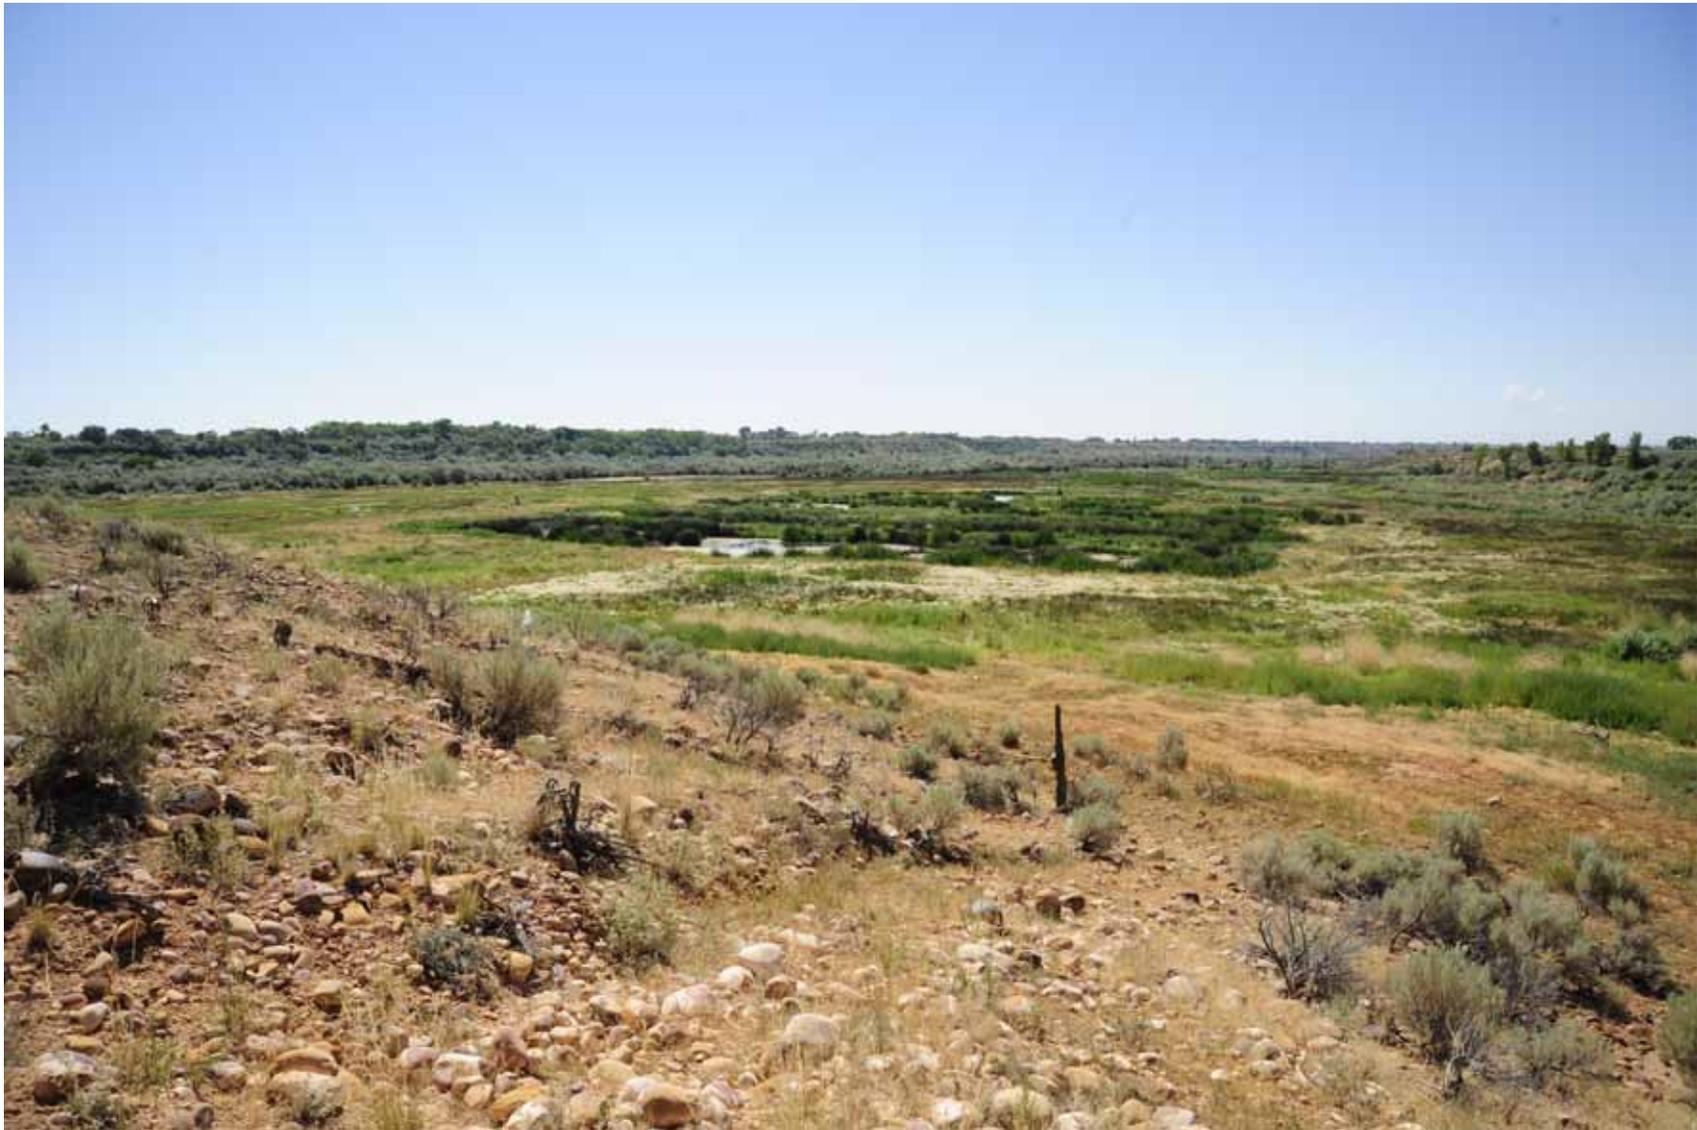
Recent photos of the constructed wetlands are shown in Figures 14, and 15. Water for the wetlands comes primarily from groundwater in the spring, but later in the year water is delivered via an irrigation valve that is located north of the wetlands (Figure 16). This valve can be opened, as needed, to provide additional water for the wetlands.

Figure 14. Photograph of the mitigation site at the Montes Creek WMA, taken in summer of 2010. The large wetlands have revegetated well with a mixture of wetland vegetation, and some weedy species as well. Water for the project gushes up from a valve, and can be seen at center left in the photo.

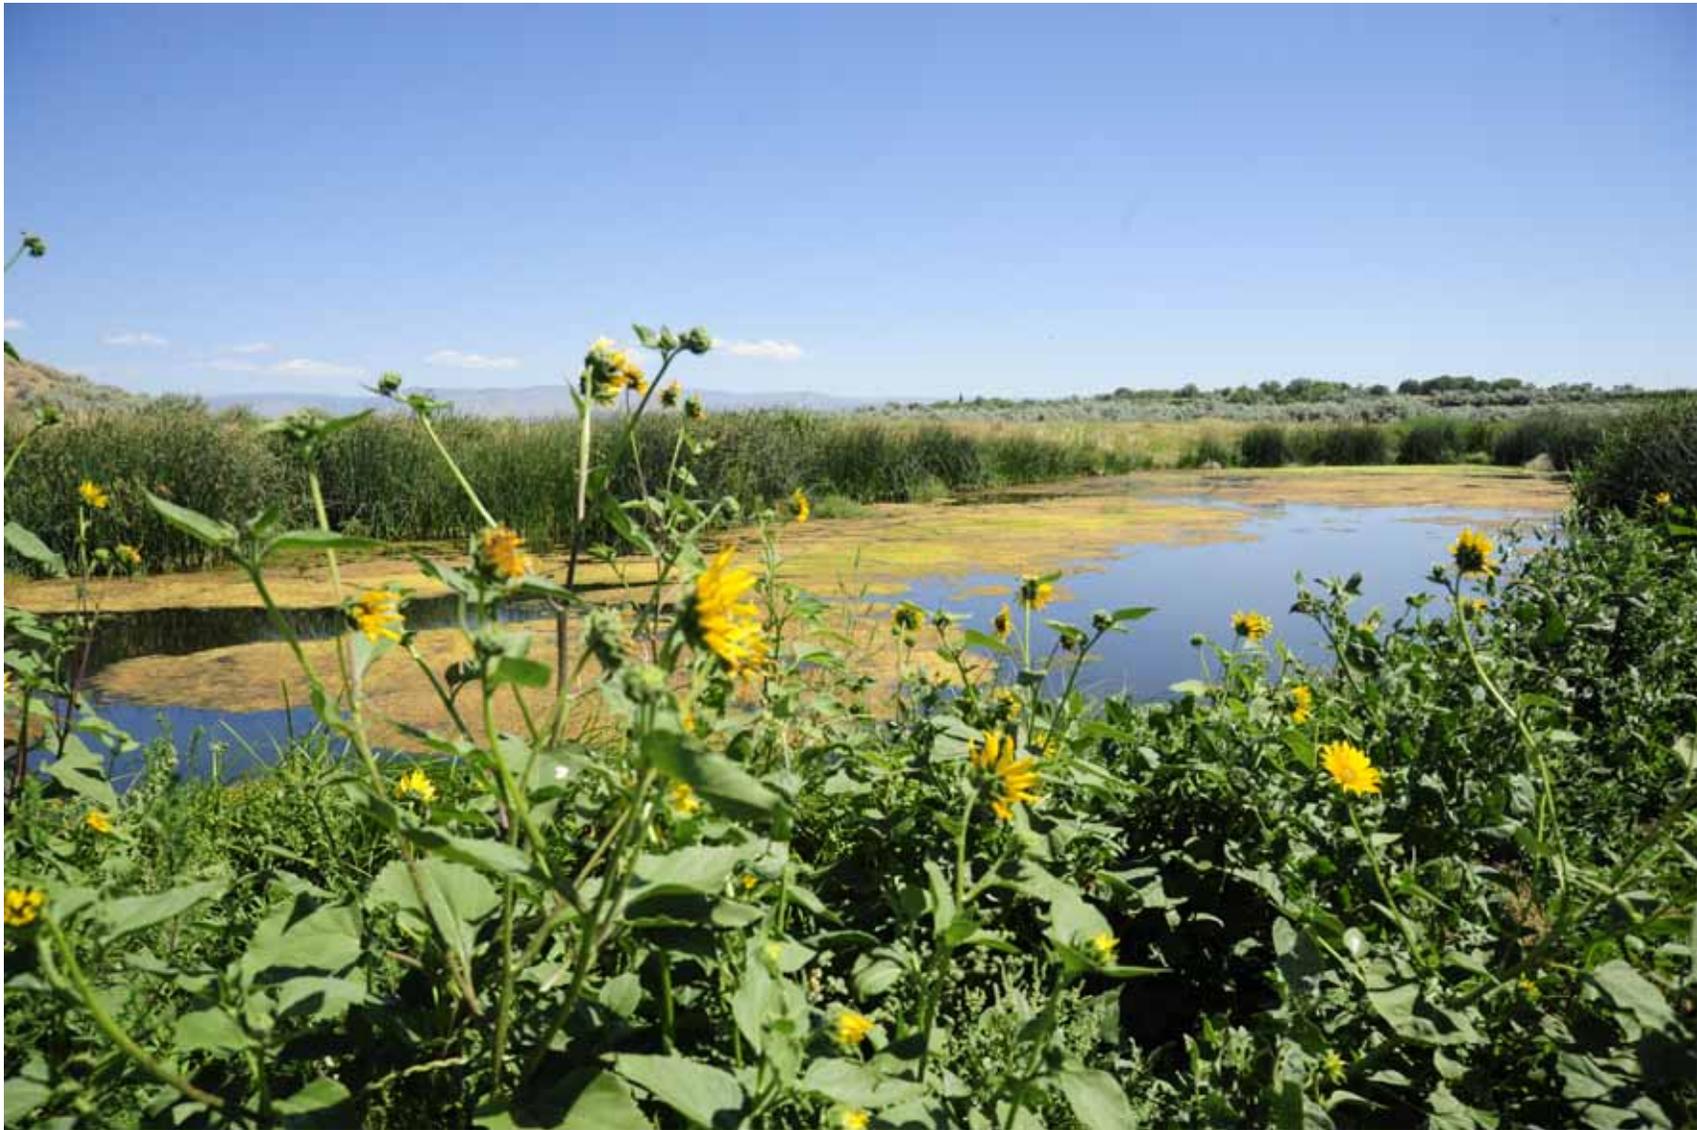
Figure 15. Photograph of the mitigation site at the Montes Creek WMA, taken in summer of 2010, showing a variety of plants that have established following construction.

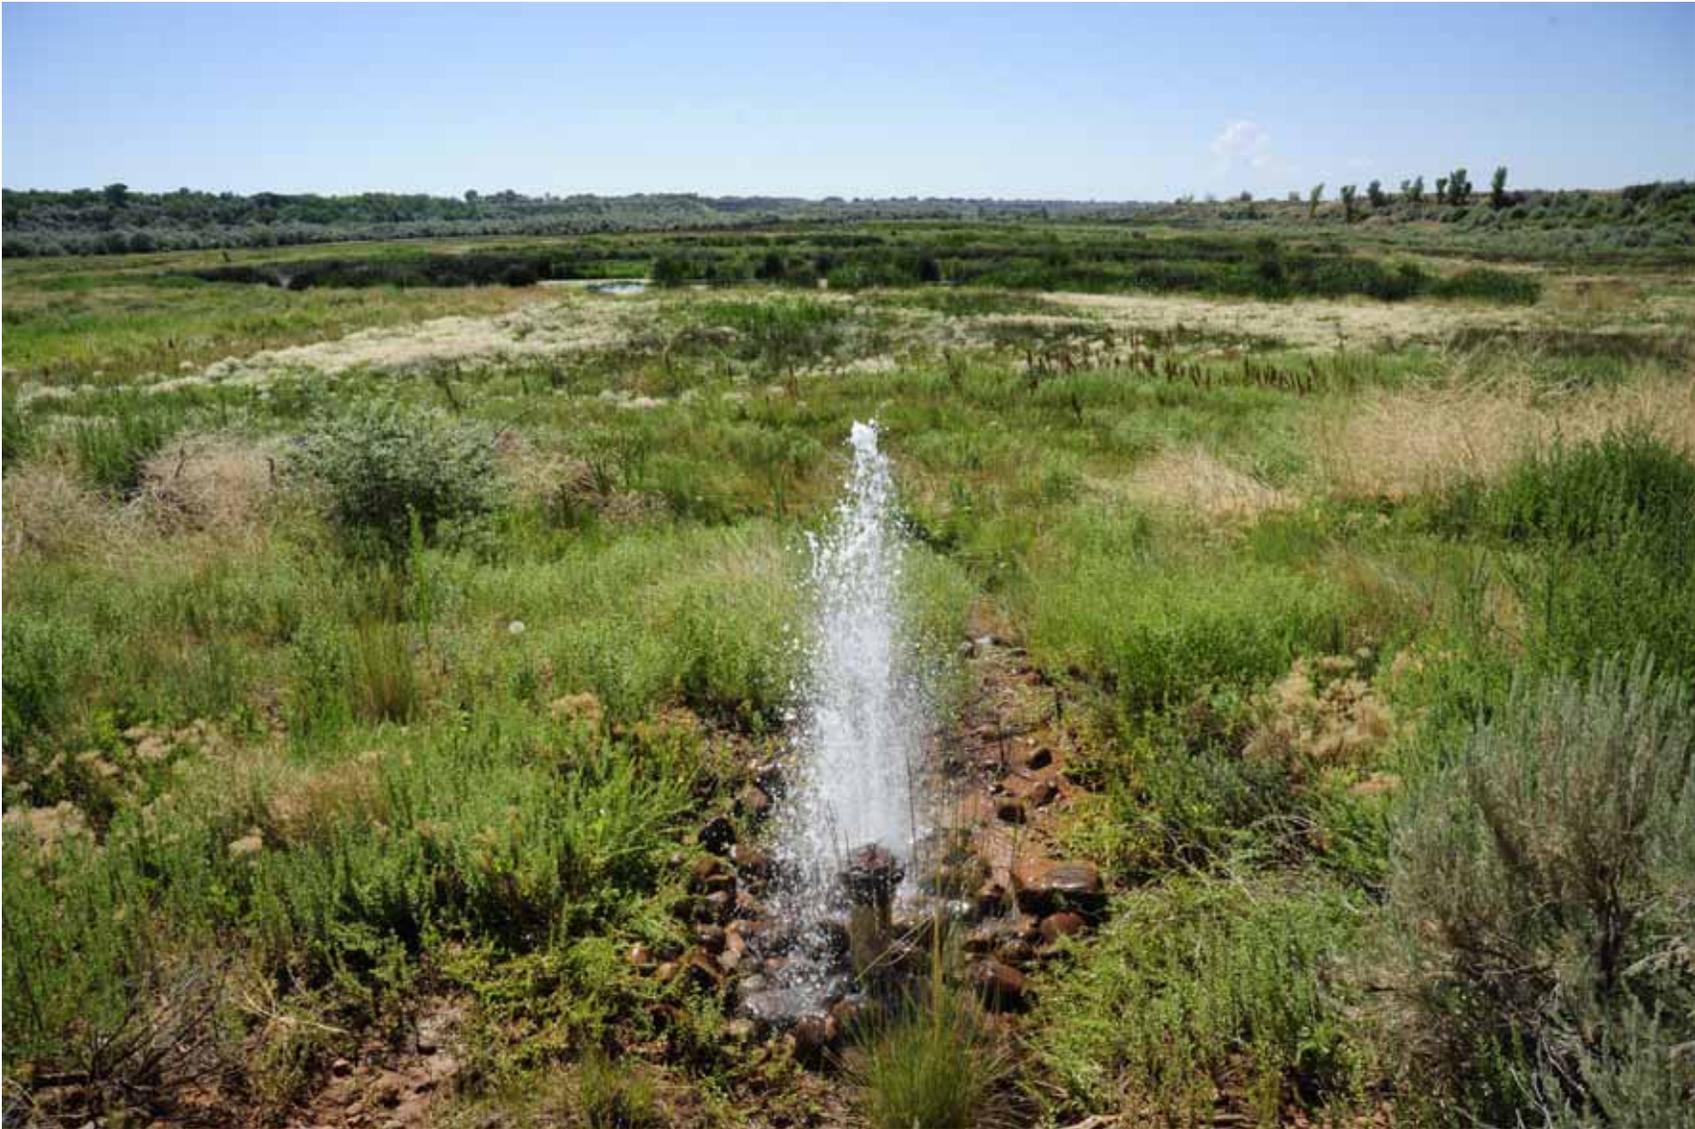
Figure 16. Photograph of the mitigation site at the Montes Creek WMA, taken in summer of 2010. This view shows the valve that provides irrigation water to the wetland cells, which are visible in the distance.

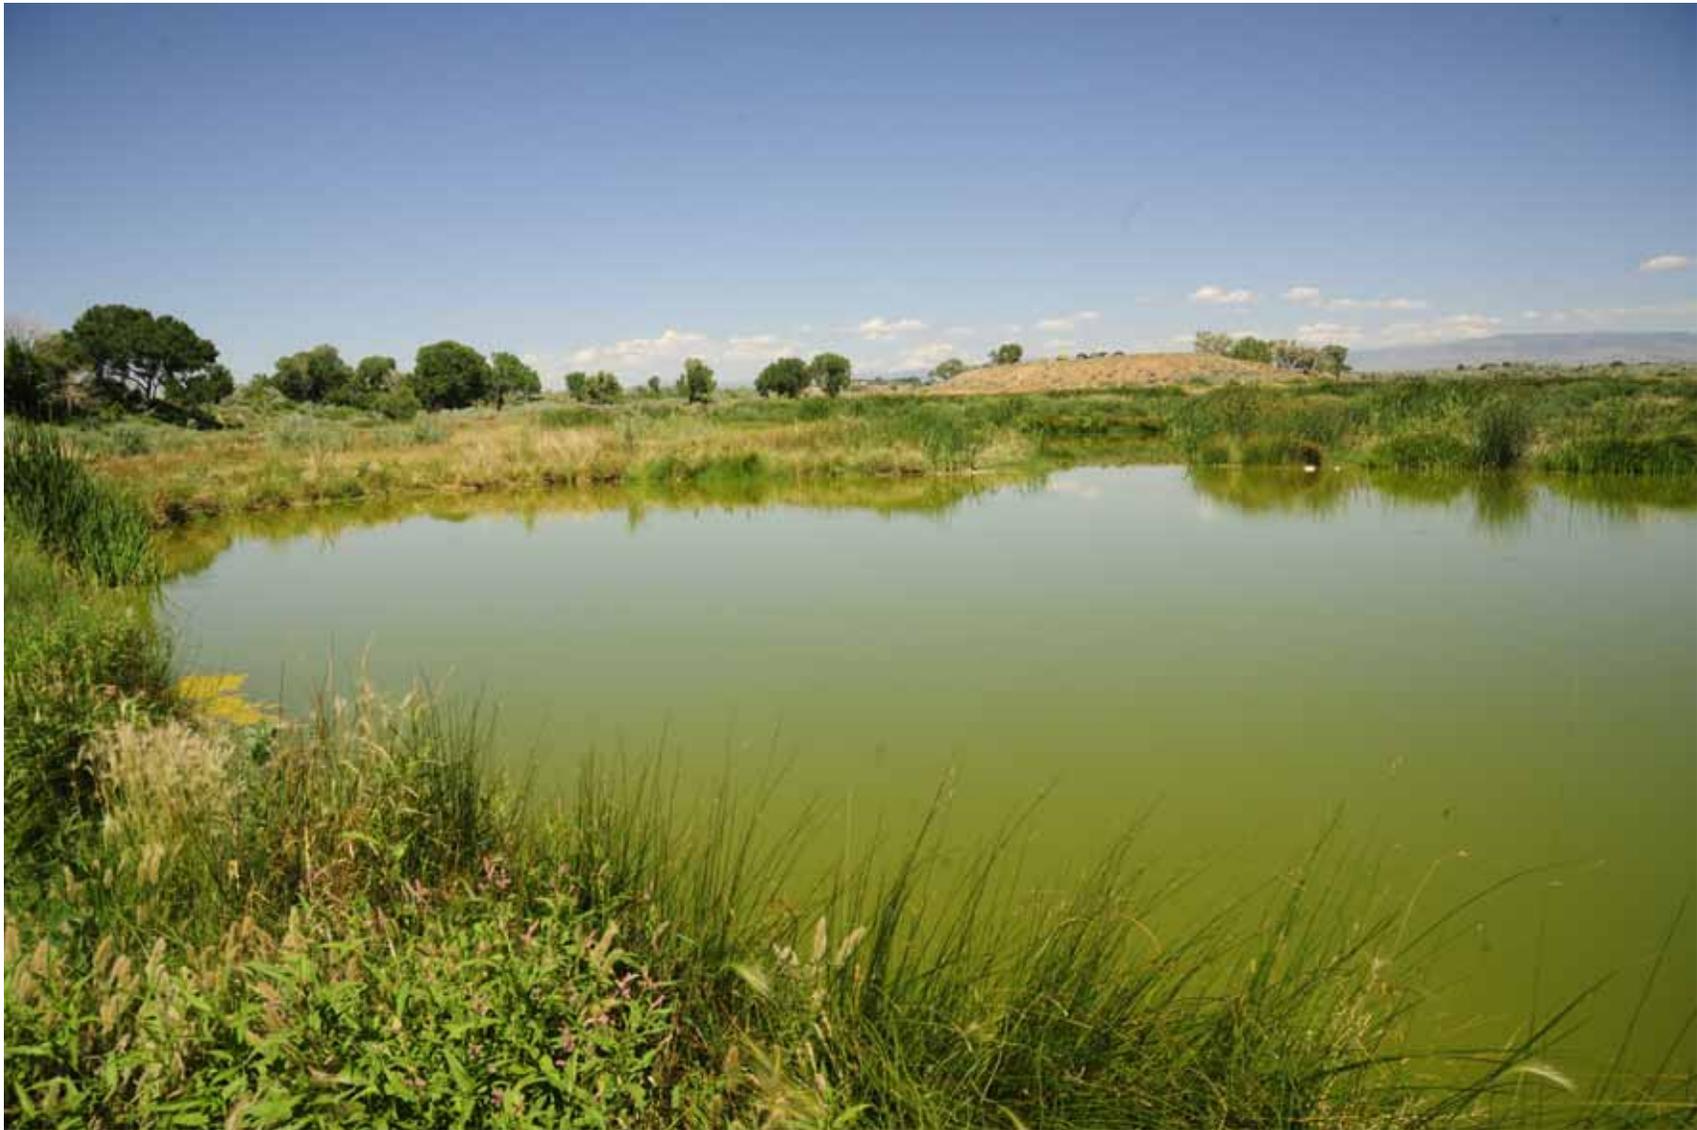
Water quality appears to change dramatically from the north to south, through the constructed wetlands. In the northern ponds, near the inflow, the water is relatively clear, with substantial amounts of floating algae present in the open-water areas. However, the southern wetlands,

which are farther from the water source, appear to have a very different water quality. In these wetlands, the water is very green and turbid (Figure 17), with little floating vegetation. The likely reason for the apparent change in water quality is nutrient enrichment from the bio-solids, which should disappear over time as the nutrients are taken up by plants and bound to sediments.

Figure 17. Photograph of the mitigation site at the Montes Creek WMA, taken in summer of 2010. This view shows the green water that is present in the two southern-most wetland cells. The northern bluff is visible in the distance.

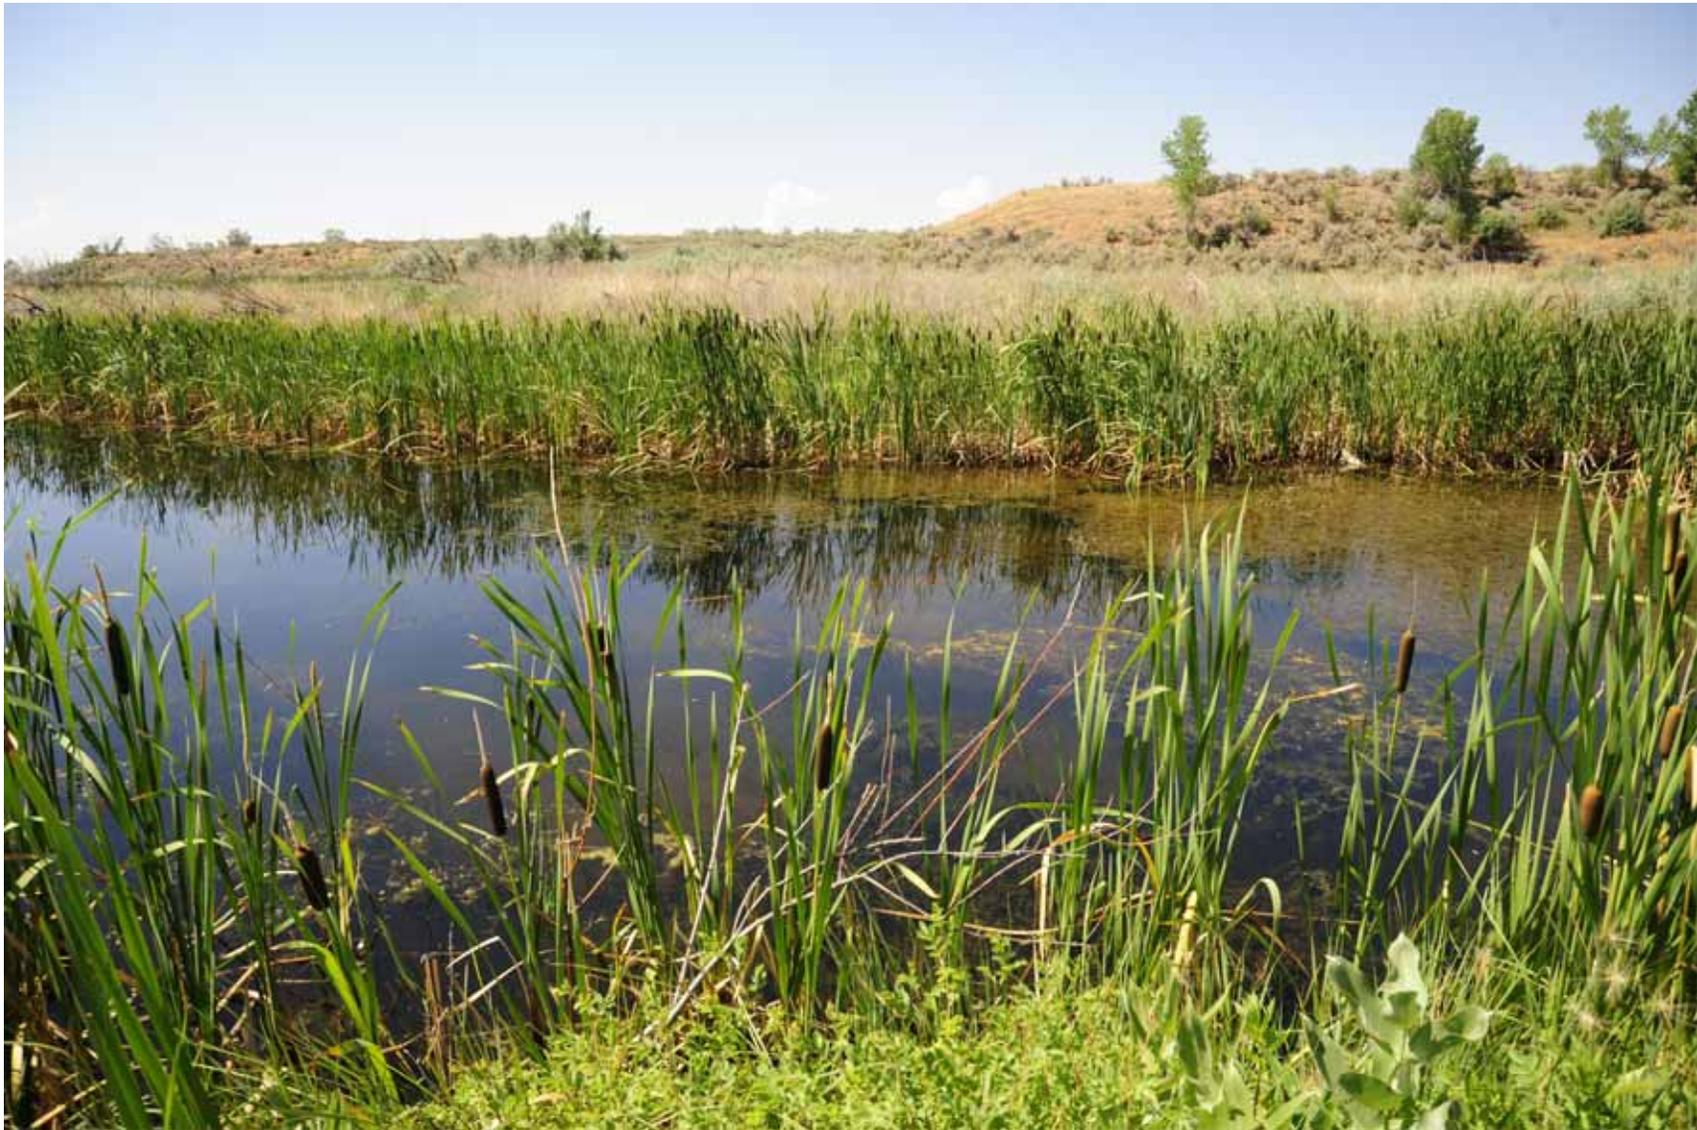
Wetland drainage ditches were excavated on the property by previous land owners, apparently with the objectives of improving livestock grazing by removing standing water and lowering the water table on a portion of the wet meadow wetland. These objectives are contrary to the goals of this mitigation project. As such, the ditches were plugged in a number of places (see Figure 9), to prevent drainage and lowering of the water table, and to promote additional wetland habitat. Ponded water is present upstream of each plug (Figure 18), which creates a mosaic of wetland habitats that are supporting a diverse population of biota.

Figure 18. Photograph of a new wetland that was created by plugging a large drainage ditch. The ditch was plugged in several locations; each plug creating a small backwater wetland similar to the one shown here.
