## Provo River Restoration Project Before & After (1999-2001)

A s part of its mitigation program, the Utah Reclamation Mitigation and Conservation Commission developed the Provo River Restoration Project (PRRP). It is restoring twelve miles of the middle Provo River between Jordanelle Dam and Deer Creek Reservoir in Wasatch County, Utah. This section of river was channelized and diked in the 1950's and 60's and consequently lost many of its abundant natural resources, such as riparian forests, emergent wetland, backwaters and deep fishing holes. PRRP's objective is to realign the river to a more natural channel pattern and regain the vegetative and wildlife resources once supported by the river. Restoration construction activities create many new landscape features. During these activities, some riverine, wetland and upland areas are disturbed. The Commission actively revegetates constructed features and disturbed areas with native, local plant materials as each construction phase is completed. Restoration is intended to advance the sequence of natural succession and result in additional habitat diversity for wildlife.

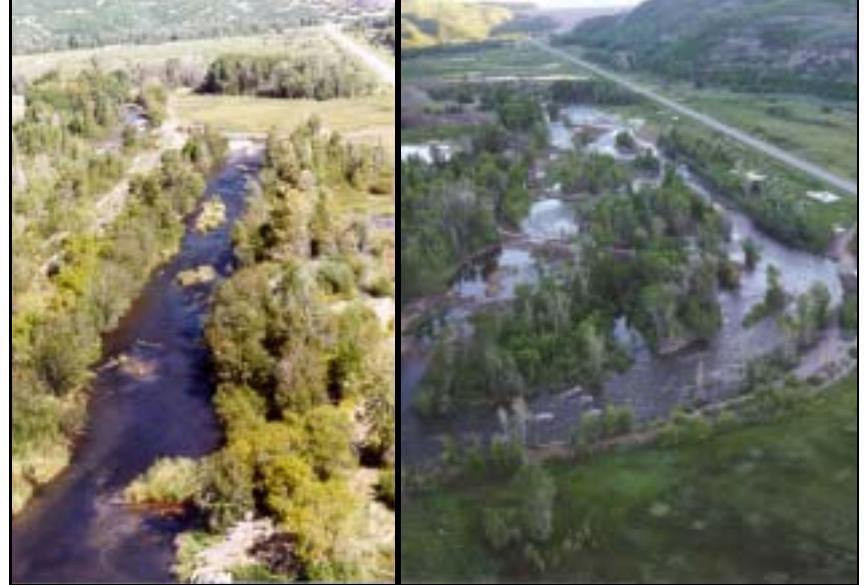
**P**RRP began construction with a "Pilot Project" that was initiated April 1, 1999 and completed in December, 1999. The area covered approximately 1.45 miles, starting about 1.6 miles downstream of Jordanelle Dam and ending where the river crosses under Highway 40. The photos to the left show the project area before construction (far left) and after construction (right) during a flood in Spring 2000.

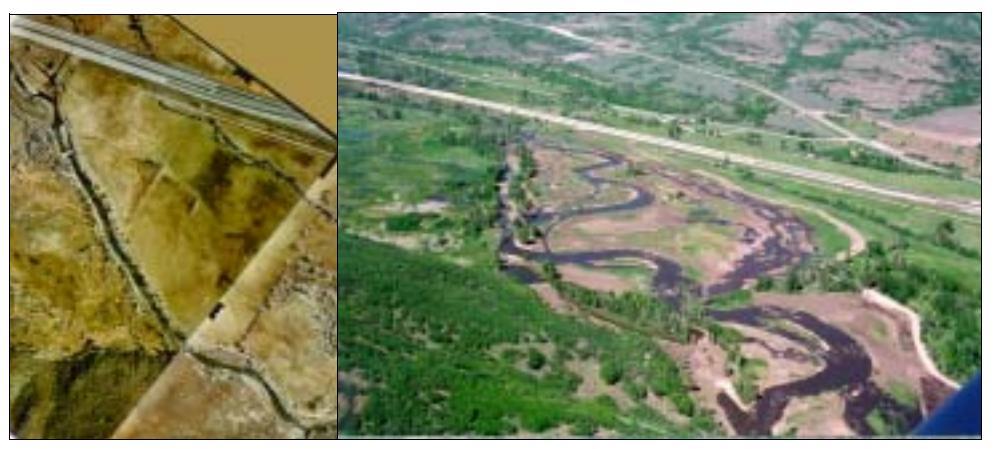
he aerial photos to the right show the PRRP 2000 project construction area, which was completed in May 2001 and began just below Highway 40 and ended at River Road in Midway. The photo to the right was taken before construction. The photo on the far right shows the project after construction during an early summer flood in 2001. While the photos are oriented at slightly different

angles the change in main channel structure, side channel habitat and expanded floodplain is apparent.

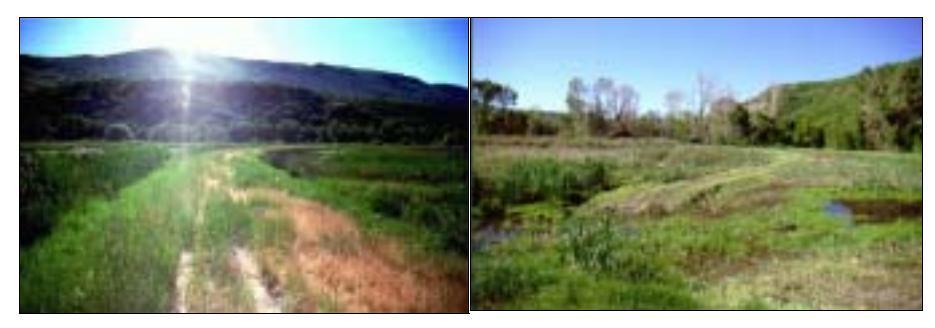
A n example of construction disturbance is shown below left where a wetland is under construction in the Pilot Project area to provide additional spotted frog habitat. Prior to construction, the area was dominated by non-native pasture grasses. Though unsightly during construction, disturbed areas quickly

recover as seen below right. Within weeks following construction, native wetland plants (rushes and sedges) were colonizing the area.

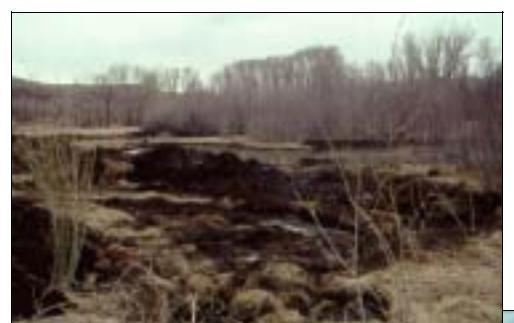
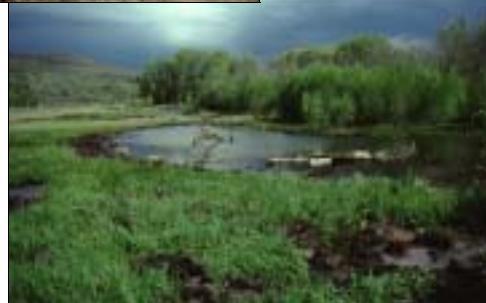
he PRRP 2000 project took the main channel of the Provo River into new meanders in an open field. The work was conducted primarily from September through December, 2000 with minor addition in Spring, 2001. As a new meander was excavated the main channel is slowly diked to prepare for a diversion of water from the main channel into the new channel. The two photos above show excavation of a new meander and the diversion of water into it.

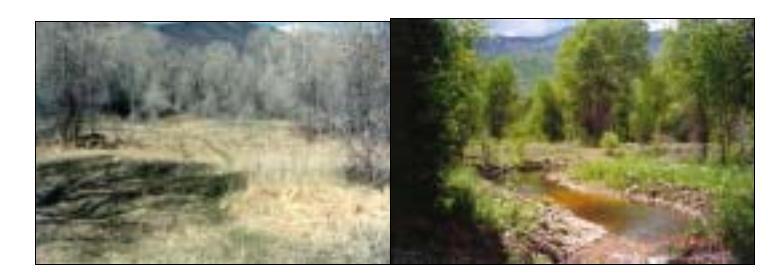
Side channels are historically important as spawning and escape habitat for native fish, such as the leatherside chub and Utah sucker. Side channels are being constructed primarily in upland areas dominated by non-native pasture grasses. They are planted with native riparian trees and shrubs, such as willow, alder, birch and dogwood. In addition to providing habitat for fish, side channels provide important riparian habitat for birds and mammals. The photos below show an area in the Pilot Project where a side channel existed historically (left). The photo to the right shows the side channel three months after construction through the PRRP.
